Details of the Parkersburg Storm Damage Survey

Below is a map of the worst damage in Parkersburg from the May 25, 2008 Parkersburg, Iowa tornado which continued for 43 miles to near New Hartford and points east. This is a detailed summary of the main core of EF4 and EF5 damage as surveyed by two storm survey teams on Monday May 26 and Tuesday May 27. The yellow path on the graphic represents the EF4 damage path with the darker path representing the areas of EF5 damage. On the graphic below the north and south extent of the damage was located with global positioning satellites.

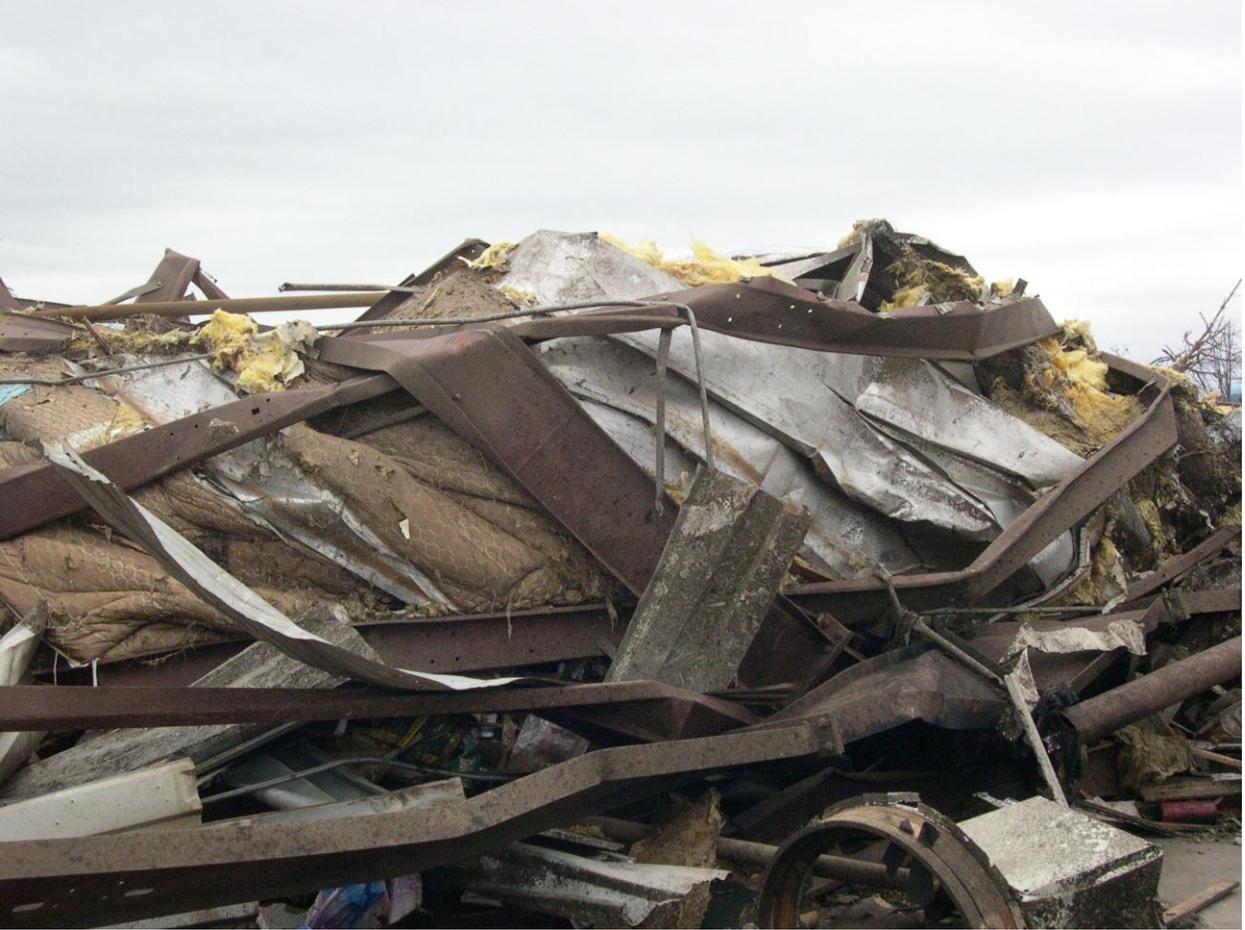
At the corner of 6th Street South and Highway 57/14 an industrial building (Figures 1 and 2) was being converted into a church suffered EF5 damage. Just from that point northeast, there was a path of EF5 damage to single family residences which were swept clean of their foundations (Figures 3, 4, 6, and 7). Along with the extensive damage to the single family homes, many trees were sheared in half with extensive examples of debarking taking place on healthy, full grown trees (Figures 4, 5, 6, and 7). A couple of locations within this EF5 corridor also had shrubs which were nearly pulled from the ground (Figure 8). The grocery store and Pizza Ranch restaurant damage were both rated EF4 and were just outside the center of the worst damage at this location in town (Figure 9).

Figure 1 Damage to industrial building on south edge of town rated EF 5

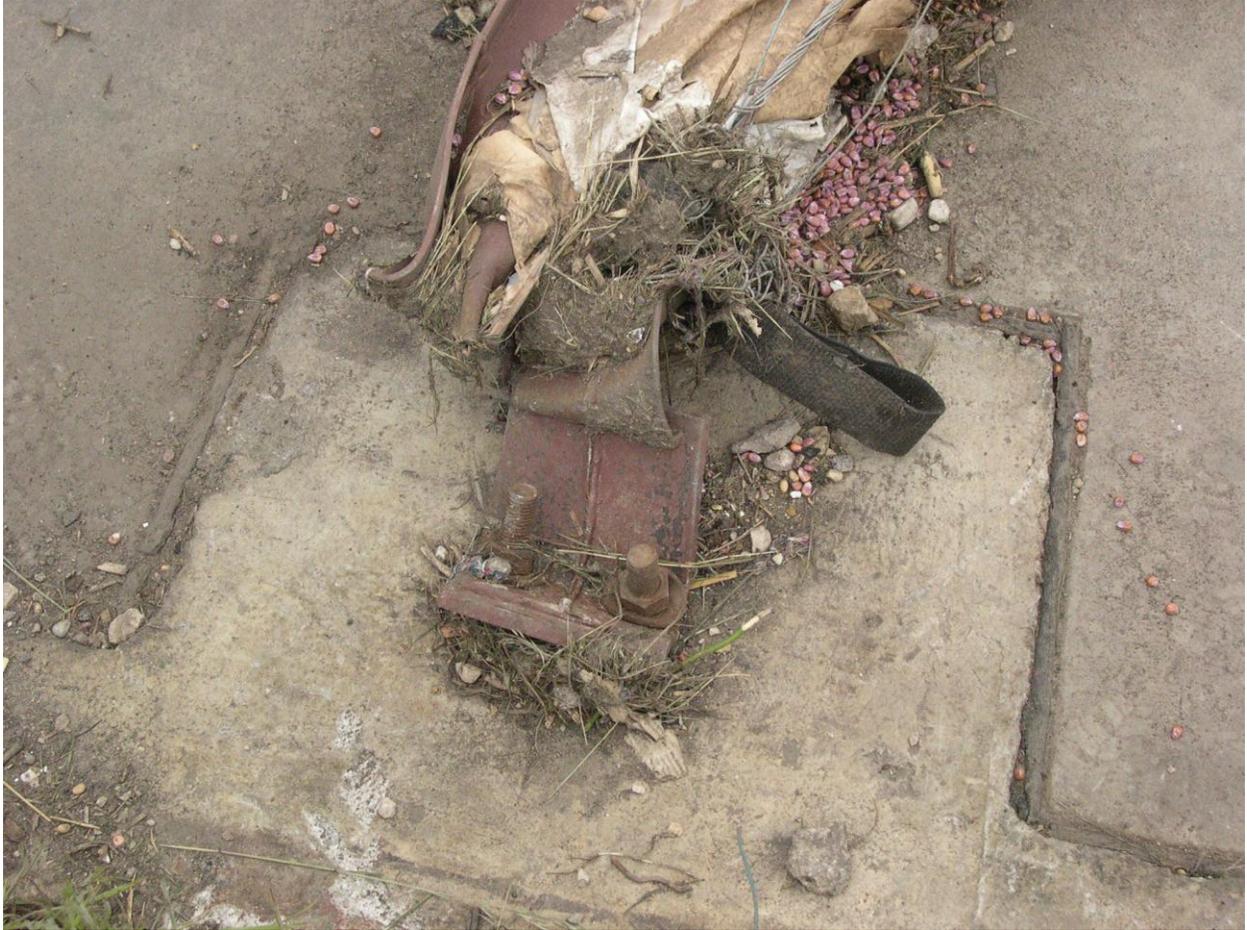
Figure 2 Metal support beams bent at base at industrial site

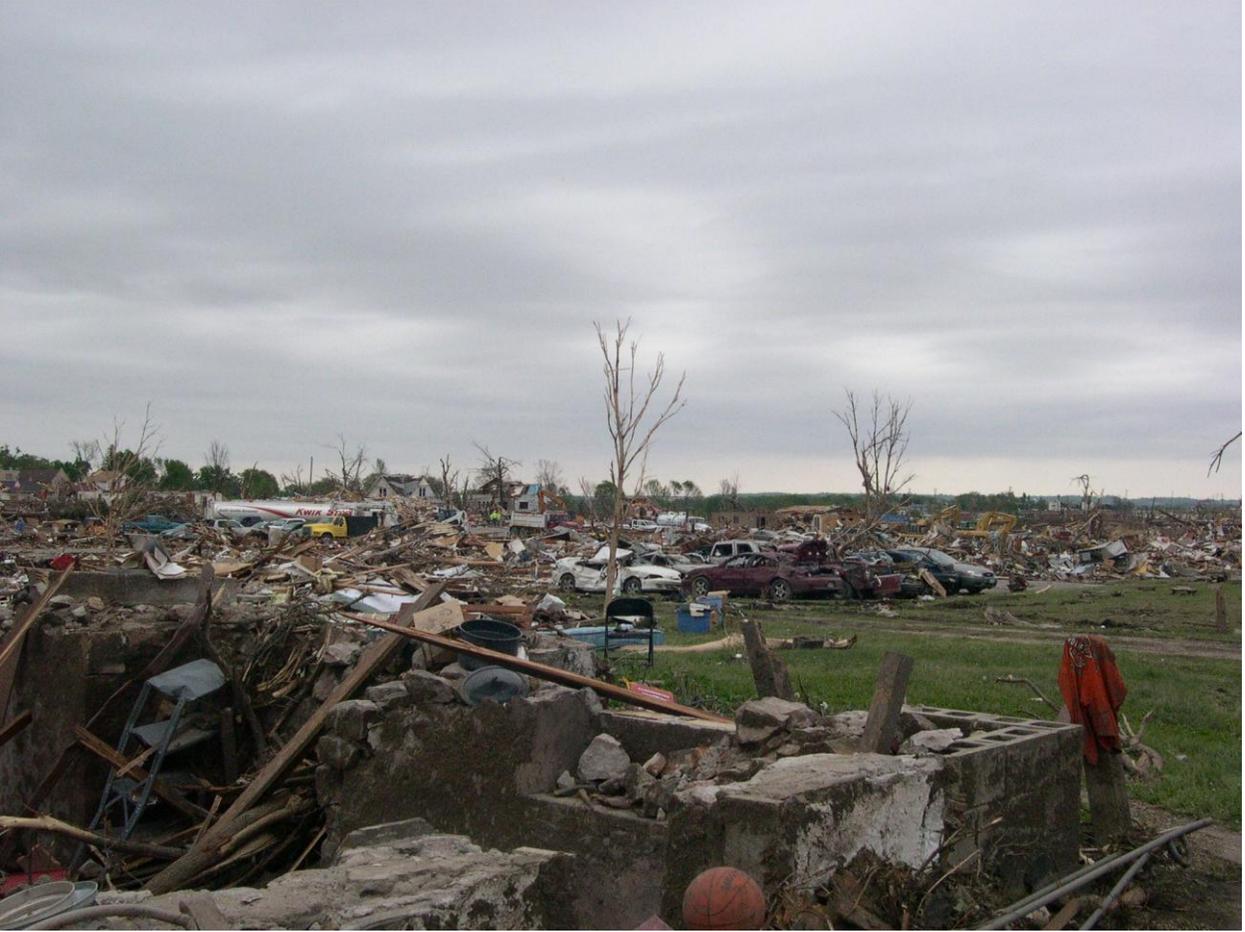
Figure 3 Main debris field of EF 4 to EF 3 damage in background

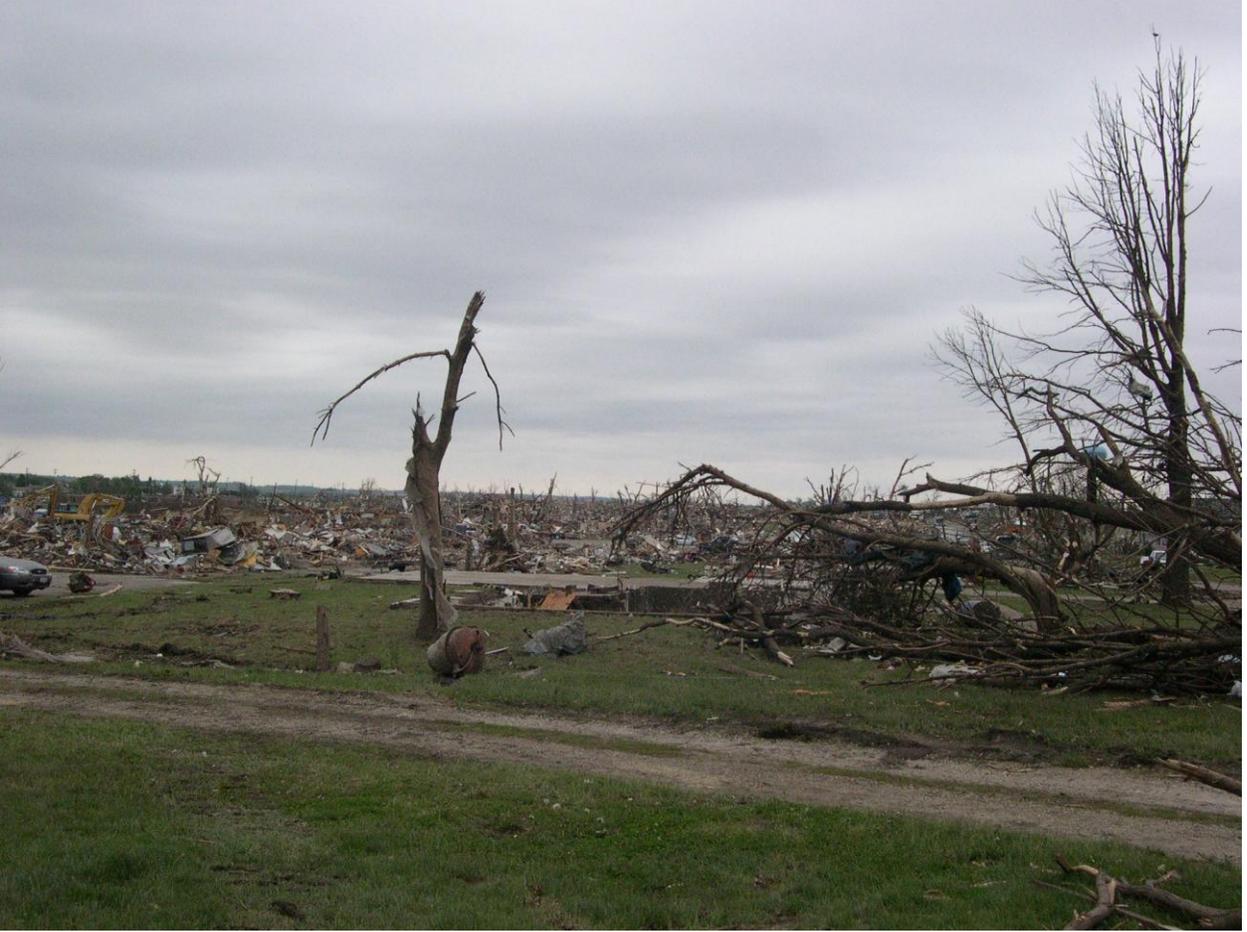
Figure 4 Main debris field of EF 5 damage

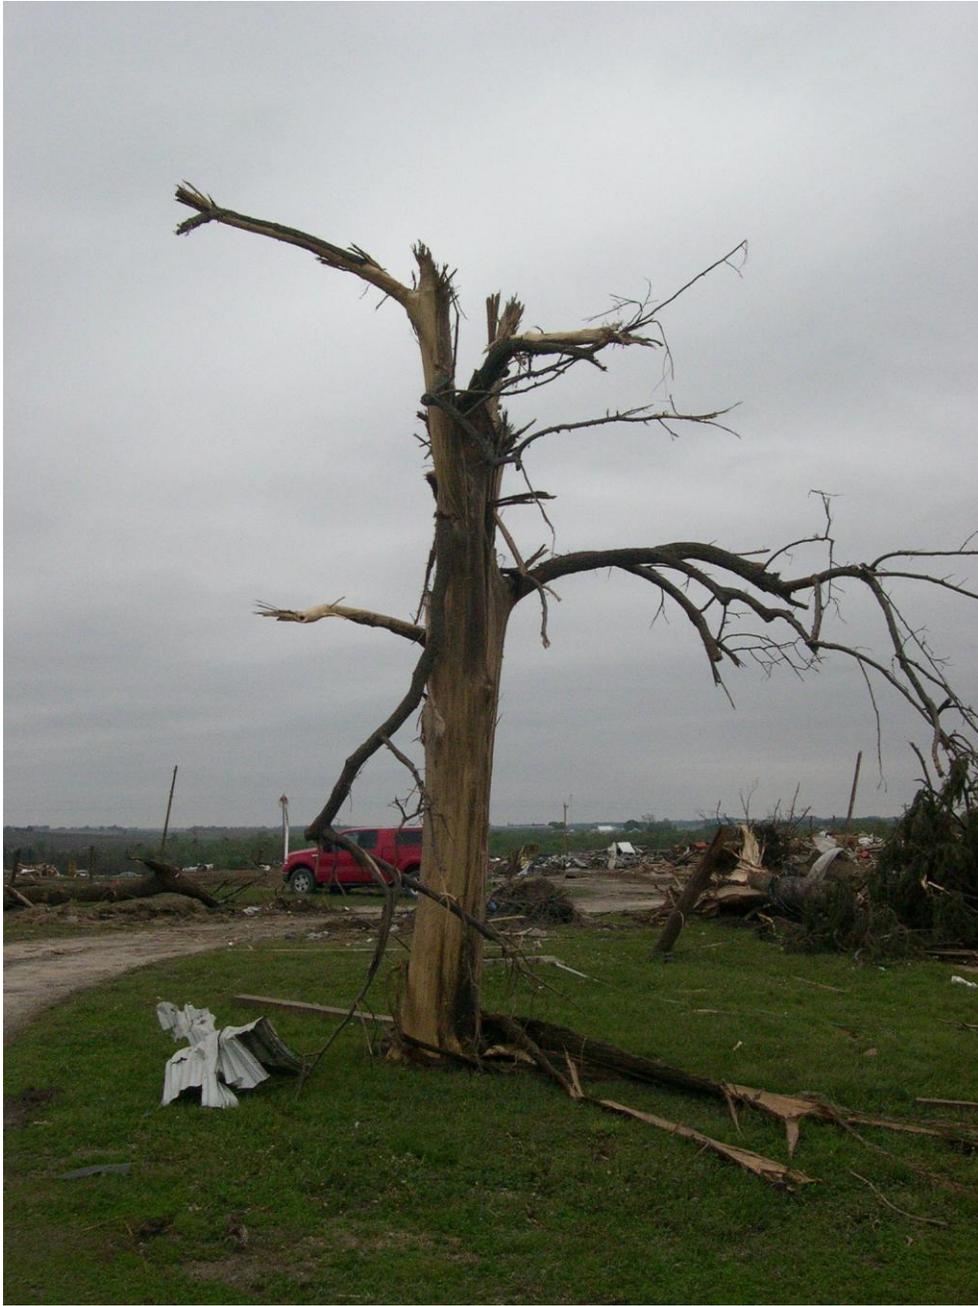
Figure 5 Totally debarked but healthy mature tree

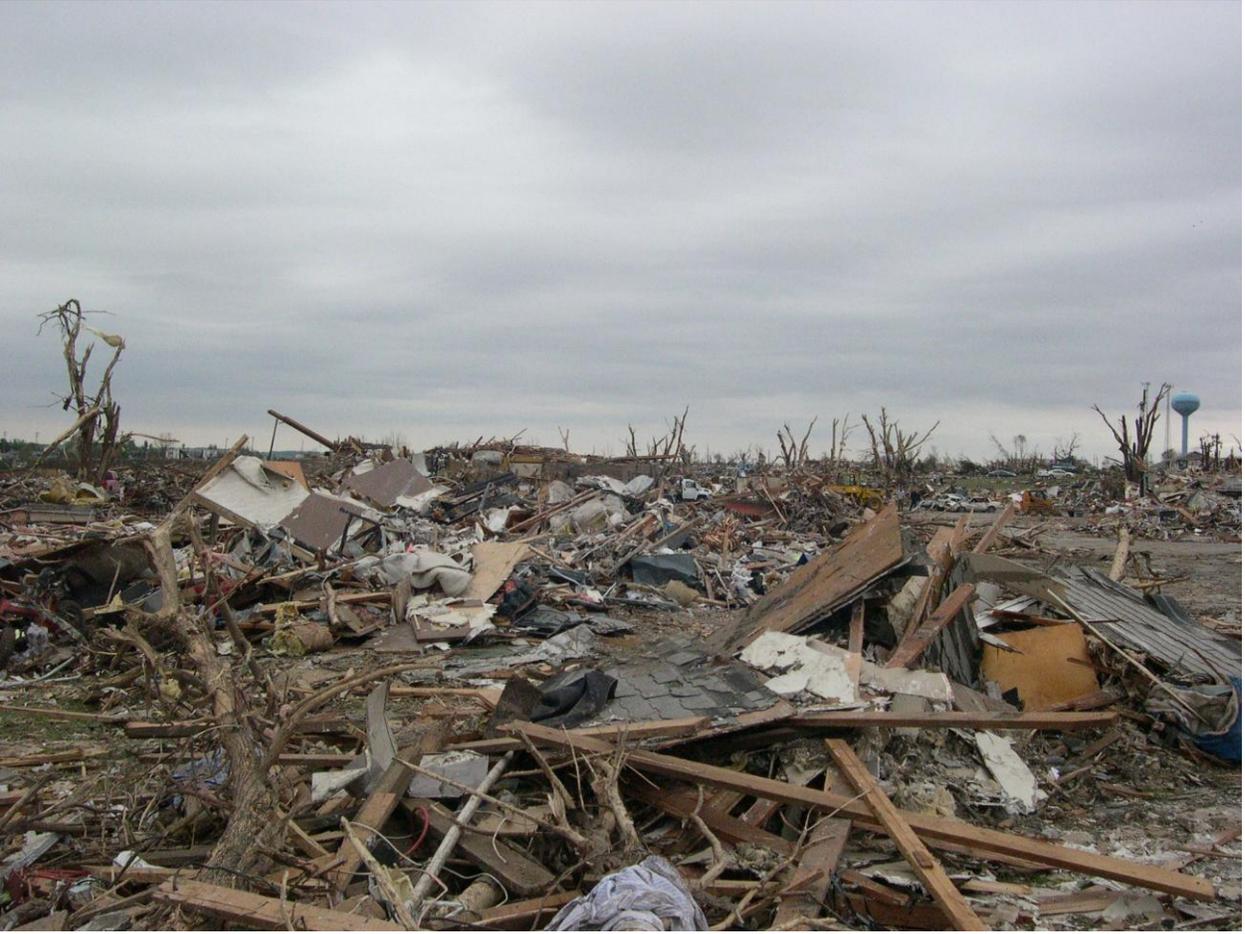
Figure 6 Main debris field of EF 5 damage

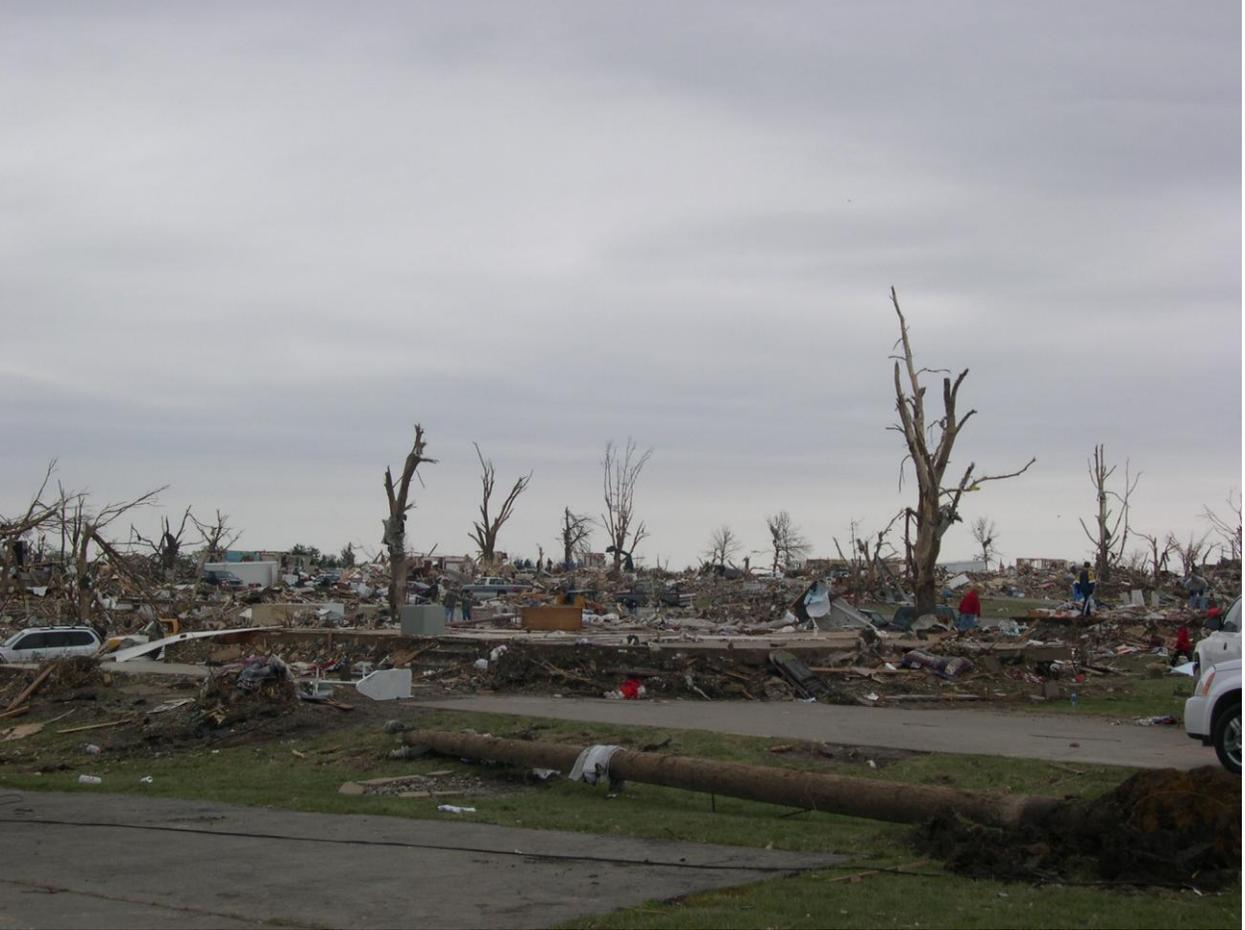
Figure 7 Main debris field of EF 5 damage with nearly all trees debarked

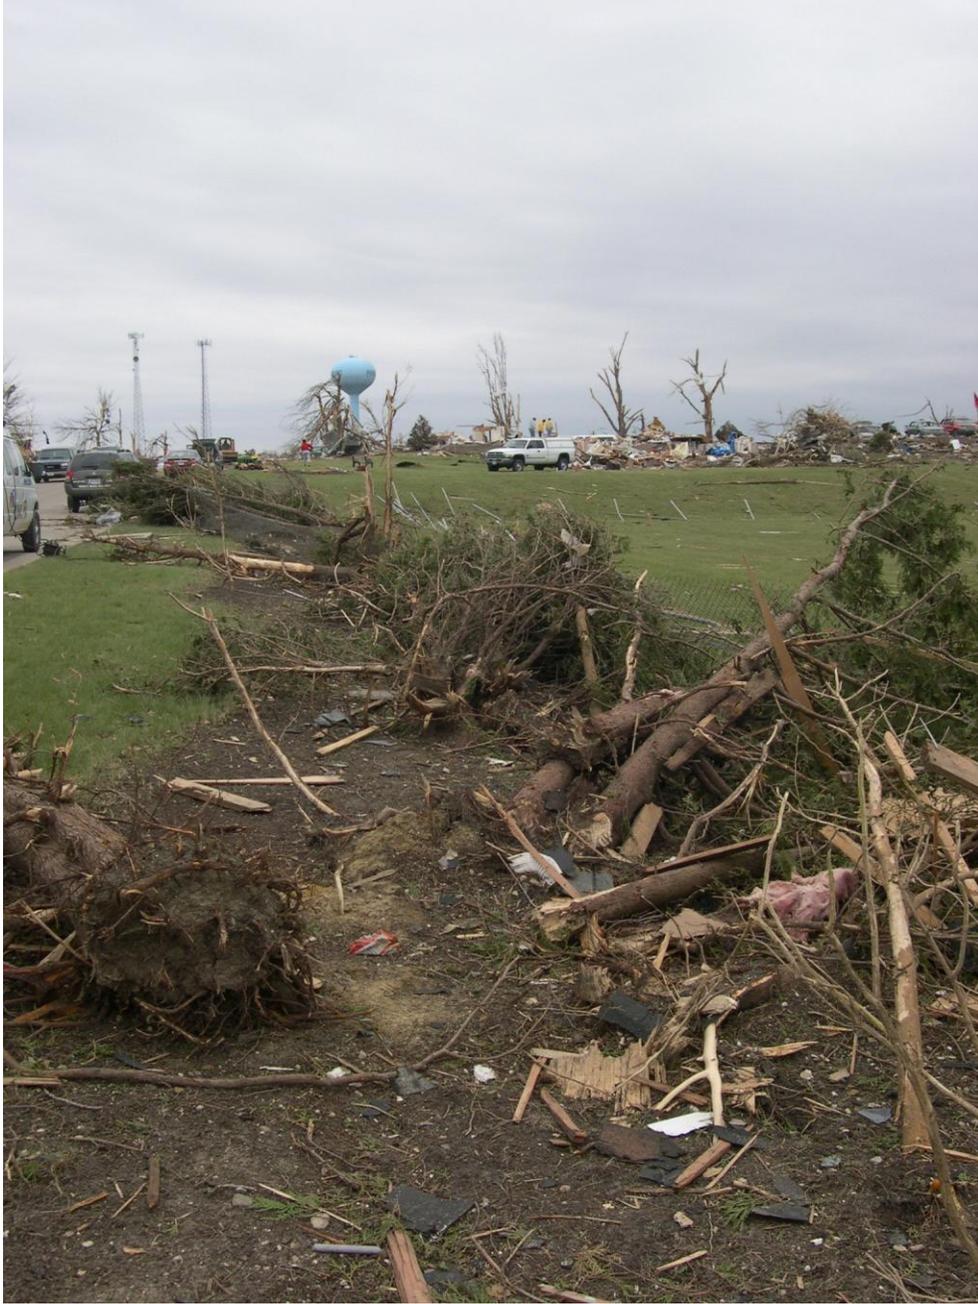
Figure 8 Evidence of shrubs nearly pulled out of the ground

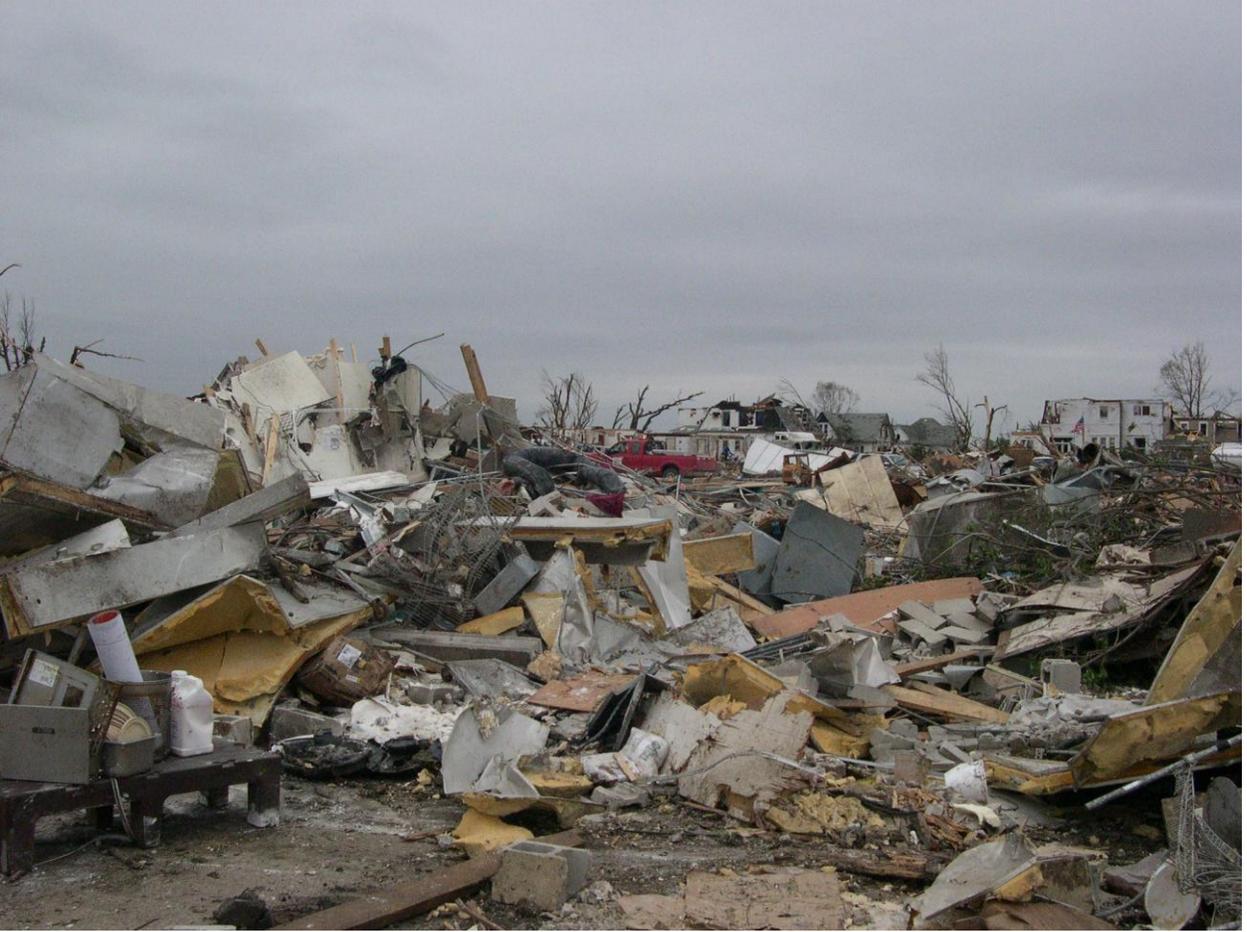
Figure 9 Pizza Ranch Restaurant rated EF 4 damage

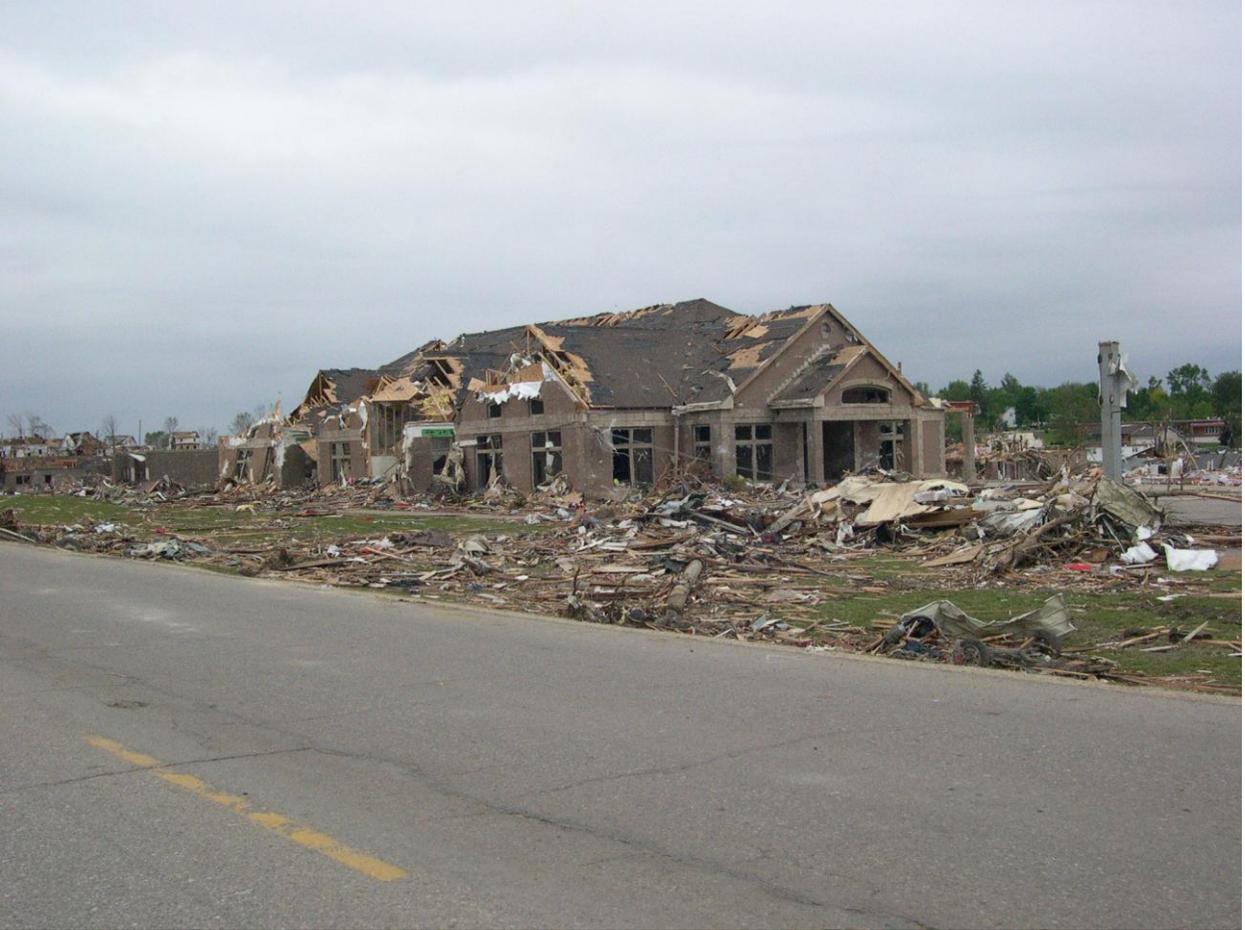
Prior to reaching North Johnson Street, both the First State Bank and local coin operated car wash suffered extensive EF2 to EF3 damage (Figures 10 and 11). Though the brick construction of these two structures helped maintain the integrity of the walls and offered additional protection to the structures, there was extensive internal damage to the wind bearing wall of the bank as well as interior damage and wind driven debris throughout the bank due to the ferocity of the tornadic winds.

Figure 10 First State Bank on Highway 57/14

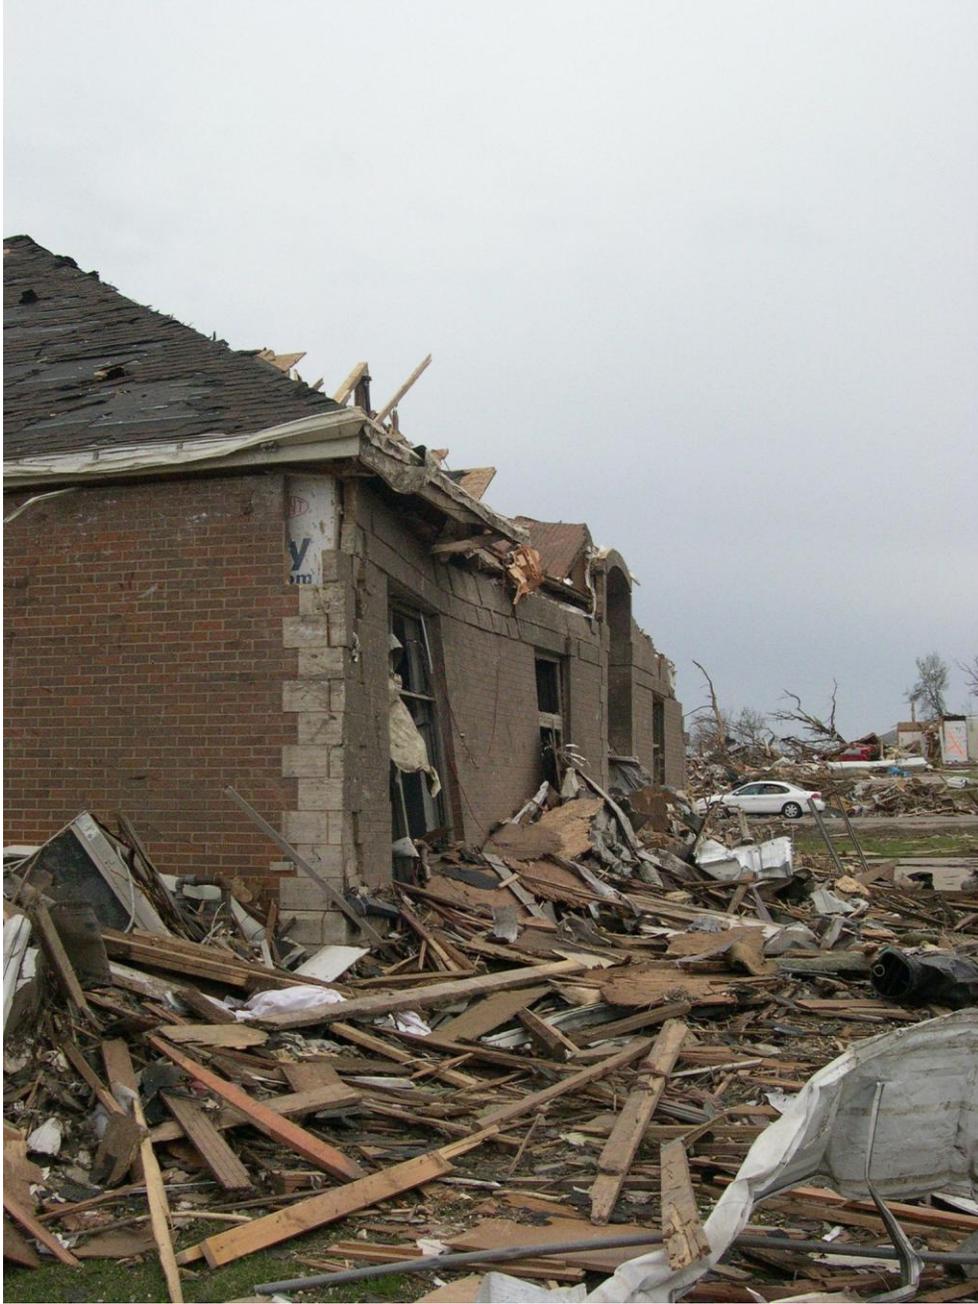
Figure 11 Initial impact at First State Bank

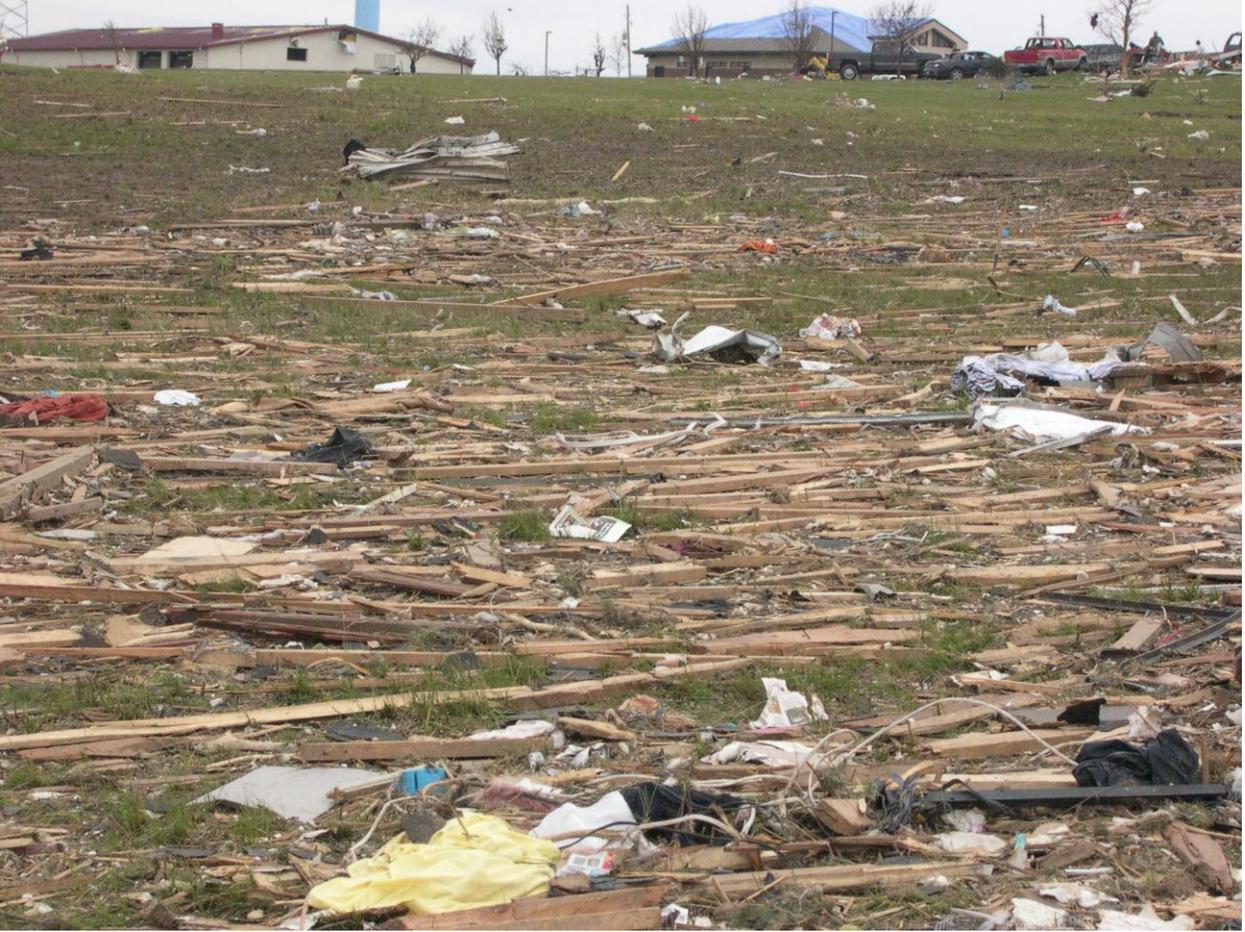
It is in this area that an extensive debris field was found with numerous medium to large sized pieces of structure along with significant granulated debris (Figures 12 and 13). After crossing Newell Avenue, the tornado continued over a golf course toward a new subdivision which consisted of construction from the past three years.

Figure 12 Extensive debris field east of Florence Street

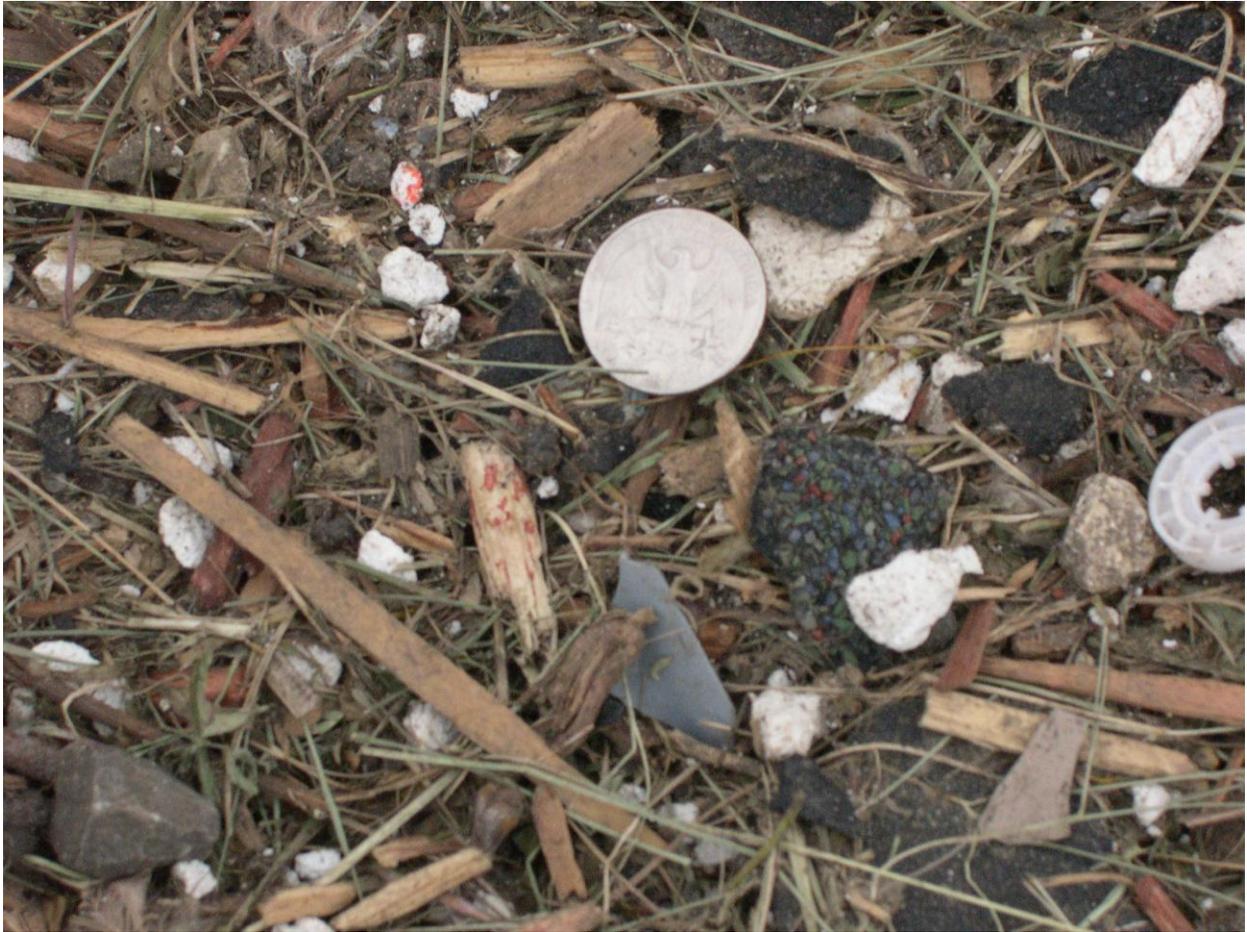
Figure 13 Fine granulated structural debris. A quarter is placed for size comparison.

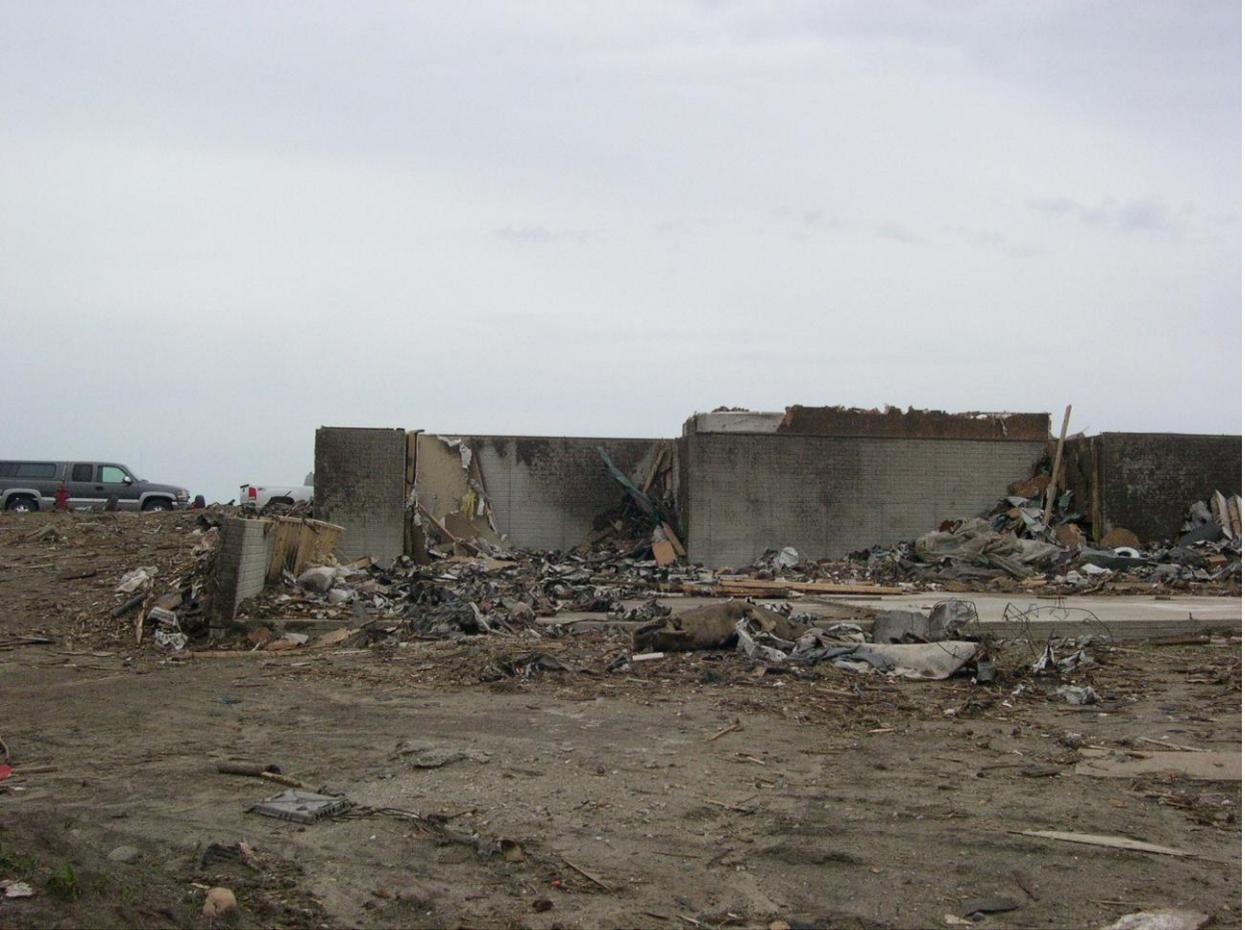
Two structures were removed from site with no debris within view of the area downstream. This area was rated low end EF5 as one structure having been built this year with above standard construction methods was swept clean of its foundation (Figures 14 and 15).

Figure 14 Newly constructed home in 2008 completely leveled. Debris collected in basement is from Parkersburg to the west. Wind bearing basement wall pushed inward and basement floor cracked at the wall – floor juncture.

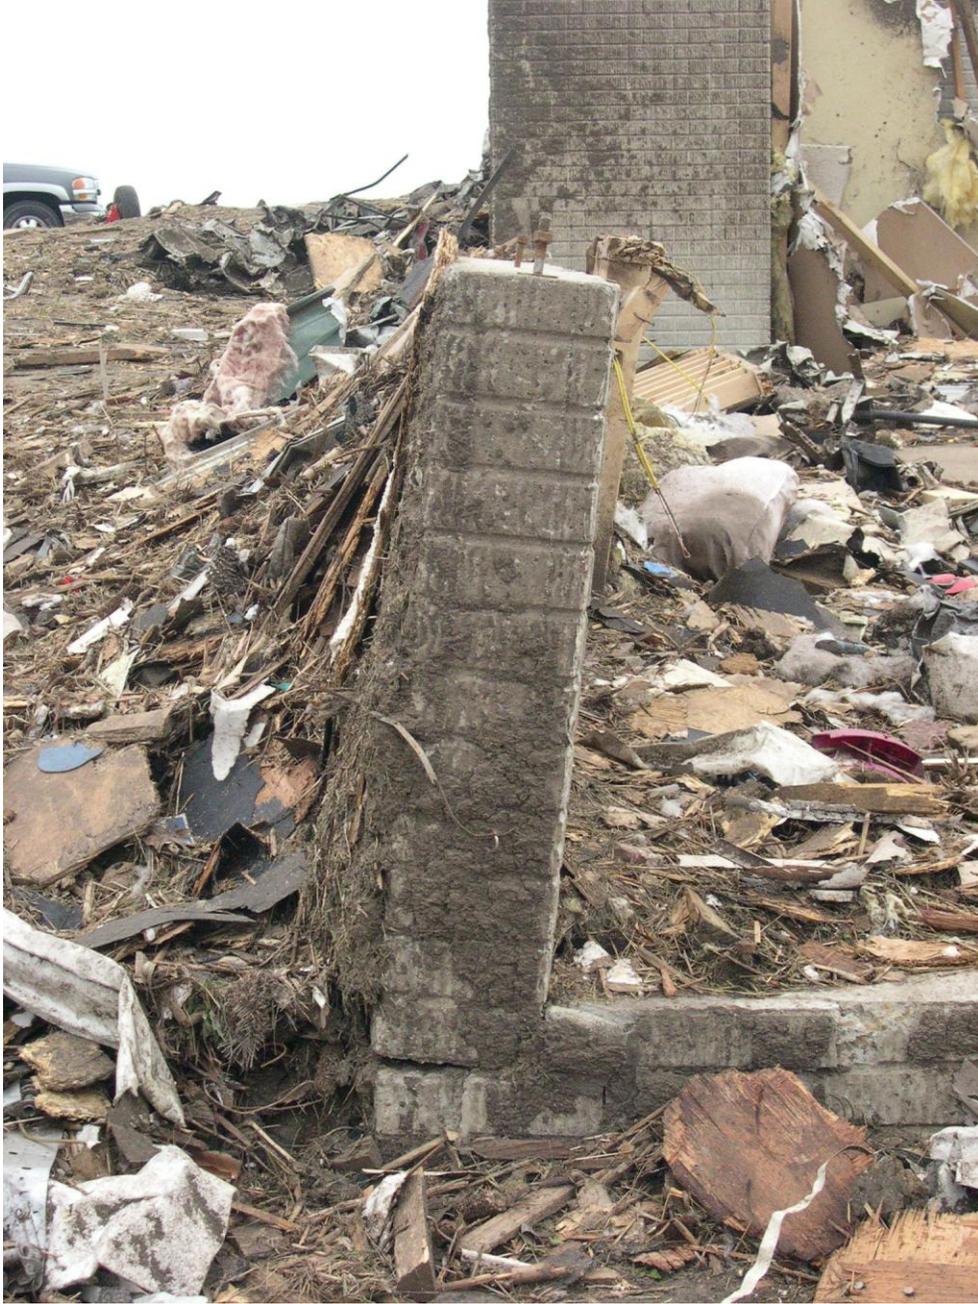
Figure 15 Close up of wall with debris from town
