Preliminary Damage Survey Report:
Wind Damage Event
1 mile North of Ellicott – 5 miles North of Ellicott
May 22, 2006

1. Summary

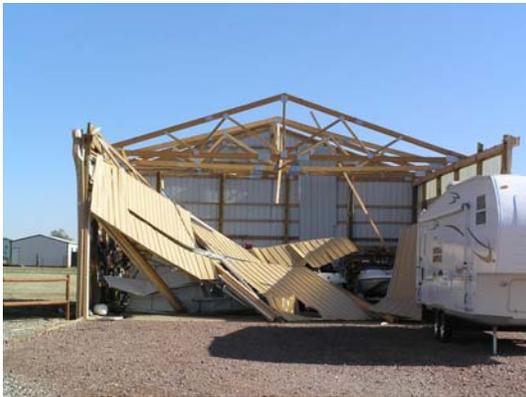
The first structure damaged (Figure 1) was a large span storage barn facility approximately 30 ft by 40 feet. This structure had an opening on the south side. It was apparent that the strong wind impacted on the south side and blew the roof off. The east,

west and north sides of the structure remained intact, although damaged. The structure was of 2x4 construction with metal siding. A 5th wheel camper trailer, as seen in Figure 1, was positioned on the south side of the structure and was moved by the wind, but was not damaged. Debris from the structure in Figure 1, mostly wood framing and metal siding, was blown northward and impacted a home approximately 200 feet to the north (Figure 2). Some of the debris actually punctured the south wall of the building shown in Figure 2. Debris was deposited in a divergent pattern over open fields north-northeast to northwest. A 3-sided shelter located about 100 yards west of the home shown in Figure 2 was also destroyed. A few pieces of metal siding or roof material from this shelter were deposited in an open field northwest of the damaged home. There were two small camper trailers sitting near another residence 150 yards northwest of the residence in Figure 2. One camper trailer was fully deployed while the other was retracted. The deployed camper was flipped over and moved about 3 feet. The other trailer was not moved nor damaged.

Figure 1. Damaged Storage Barn

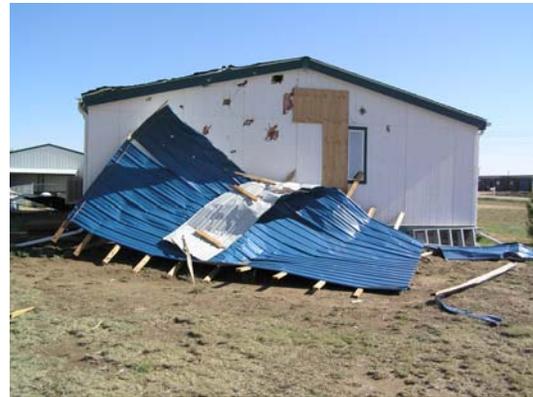
Figure 2. Home north of damaged storage barn. Roof debris from the barn is seen laying up on the side of the home.

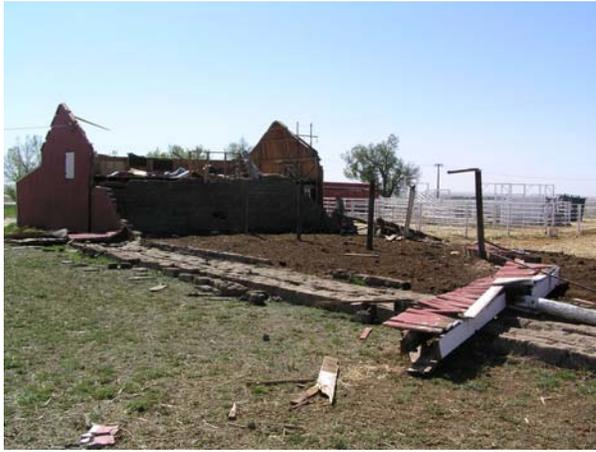
The next structure found to be damaged was a 60 year old barn made of sod or adobe style material with wood framing (Figure 3). The structure was an open pole barn that faced to the south. This structure was completely destroyed. The roof of a taller barn structure, attached to the 60 year old barn was blown off. Much of the debris from the pole barn was deposited just north of its original position. The sod walls were blown down. Debris from the taller barn structure was blown to the north and northeast impacting a small SUV and the west side of a stucco home. (Figures 3 and 4) Wood from the barn structure penetrated the stucco home on the west side leaving insulation material exposed. There was also damage to the roof. Several other structures north of the barn that appeared to be more substantially built were not damaged other than by debris impact. Some of the debris was collected along a row of trees about 180 feet north of the barn, on the other side of the more substantial structures. Smaller sections of the roof were found northwest of the structure on the other side of a small building that was not damaged.

Figure 3. 60 year old pole barn

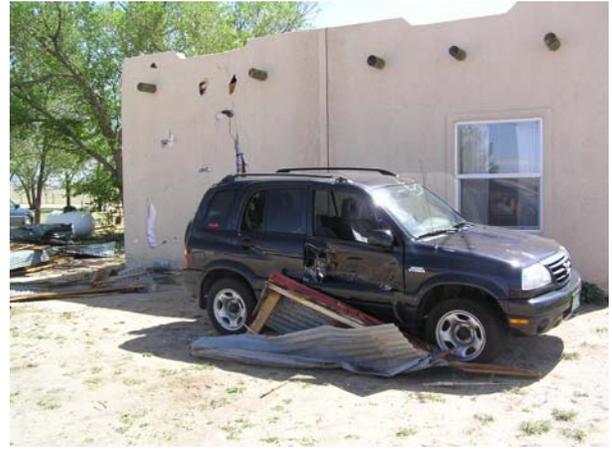
Figure 4. Car and wall with damage from debris

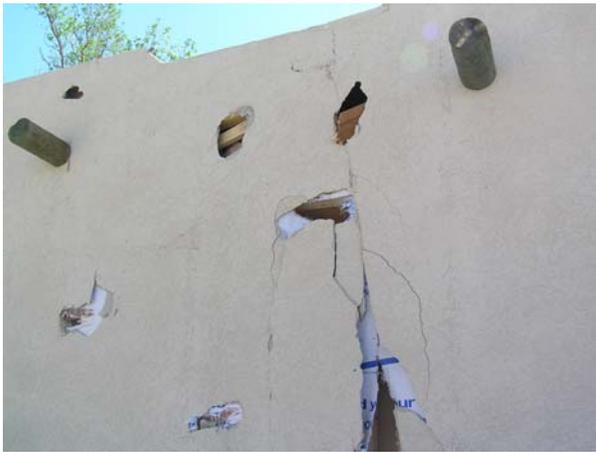
Figure 5. Debris penetrating stucco wall

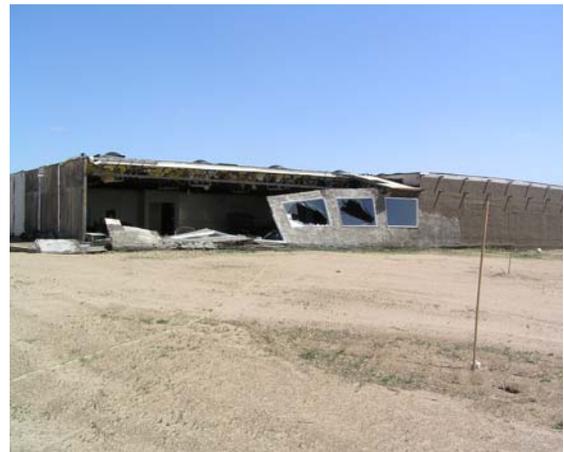
Figure 6. Storage warehouse.

A third structure (Figure 6) had damage on the south facing side. This structure was an unoccupied storage structure. It appeared that the outer walls were in the process of receiving some form of stucco covering. The south wall was pushed inward causing damage to the roof and west wall.

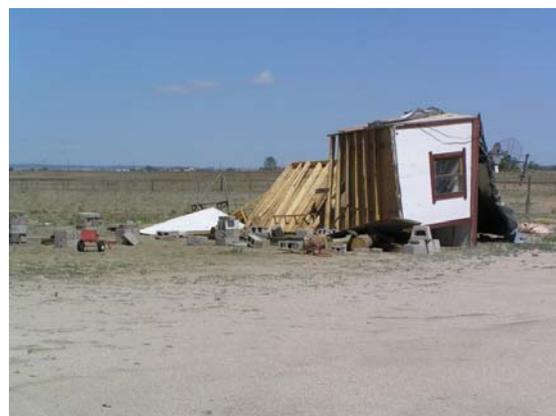
A fourth structure received substantial damage. (Figure 7) This structure was an older mobile home that was sitting on blocks. The structure did not appear to be secured to the ground by tie downs. The mobile home was positioned in an east-west direction and appeared to be perpendicular to the thunderstorm wind. The mobile home was pushed off the blocks. Some of the debris from the mobile home was deposited about 20 yards to the northeast. A more substantial mobile home was positioned in the same way about 10 yards north of the

Figure 7. Mobile home pushed and rolled

damaged mobile home. This structure received only minor damage caused by debris from the damaged mobile home.

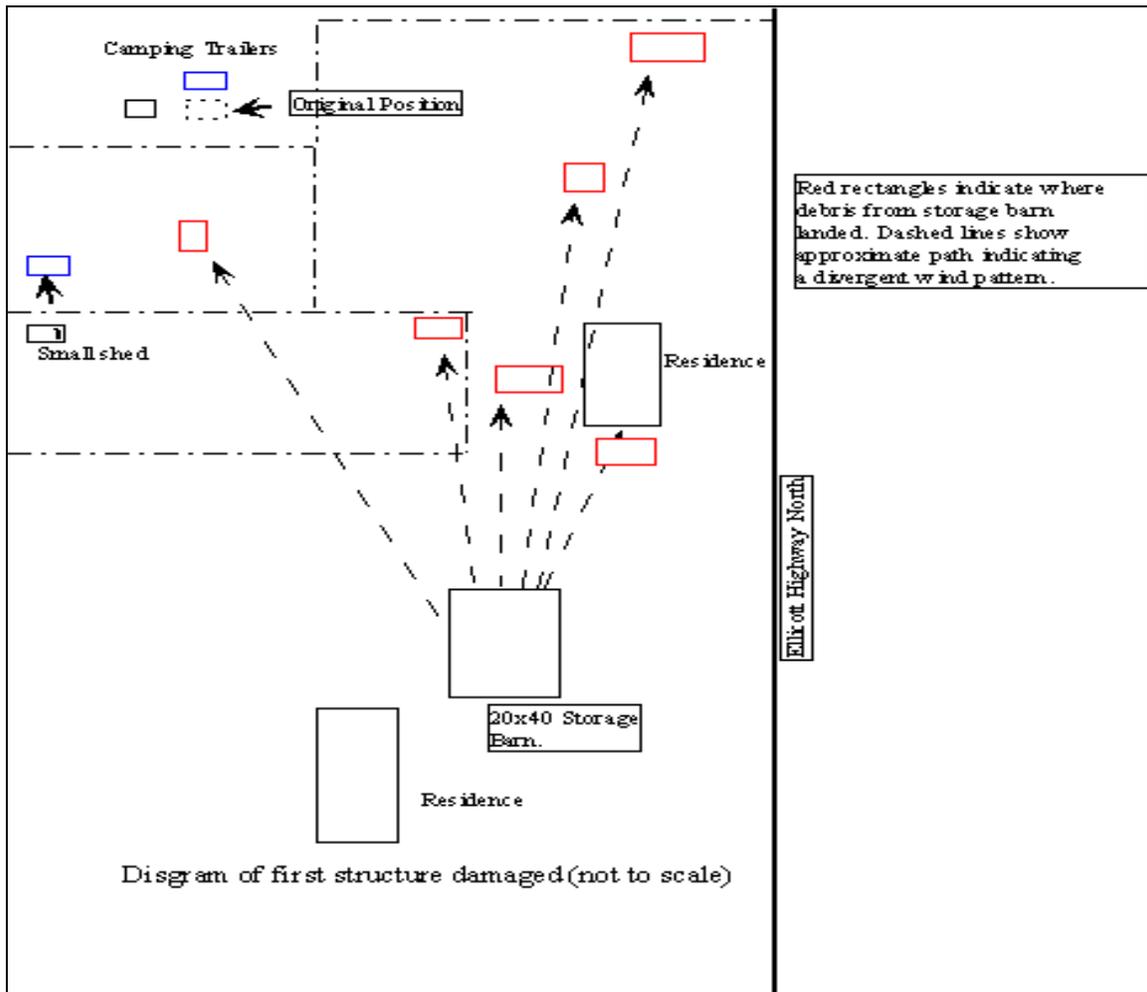
Figure 8. Diagram of debris pattern

The damage that occurred during this event was caused by straight-line wind produced by thunderstorms that moved across the area on a south to north trajectory at a speed of 40 to 50 mph. The sporadic wind damage was confined to “large span” buildings that had openings or exposures facing south and to structures that were oriented in such a way as to make them vulnerable to a south wind. Damage to other structures was caused by debris from the damaged structures. Straight-line thunderstorm winds impacted the structures at speeds possibly as high as 70-80 mph taking advantage of weak points on the south side or broad siding structures that were oriented east-west.
