# July 14, 2009: Swift Falls and Spicer Area Tornadoes

## Event Synopsis

National Weather Service personnel from the Chanhassen Forecast Office conducted a damage assessment in the Swift Falls and Spicer, Minnesota areas following the tornadoes on July 14, 2009.

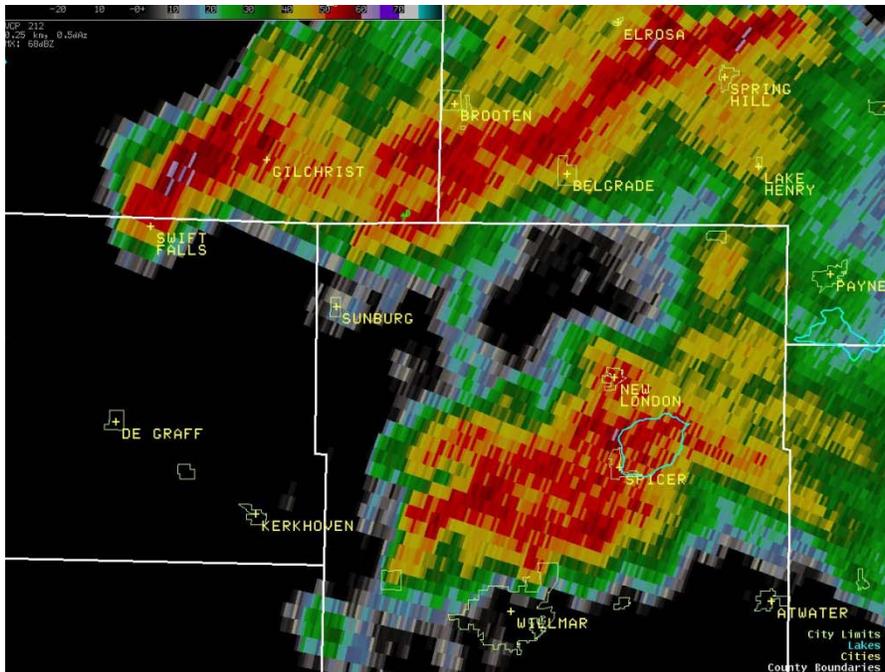
July 14, 2009: 4:24 pm Radar Image NWS Chanhassen Doppler Radar reflectivity image of the storm which had a tornado near Swift Falls at the time. To the southeast, one will note the more disorganized storm which 20 minutes later rapidly evolved into the tornado producer near Spicer.

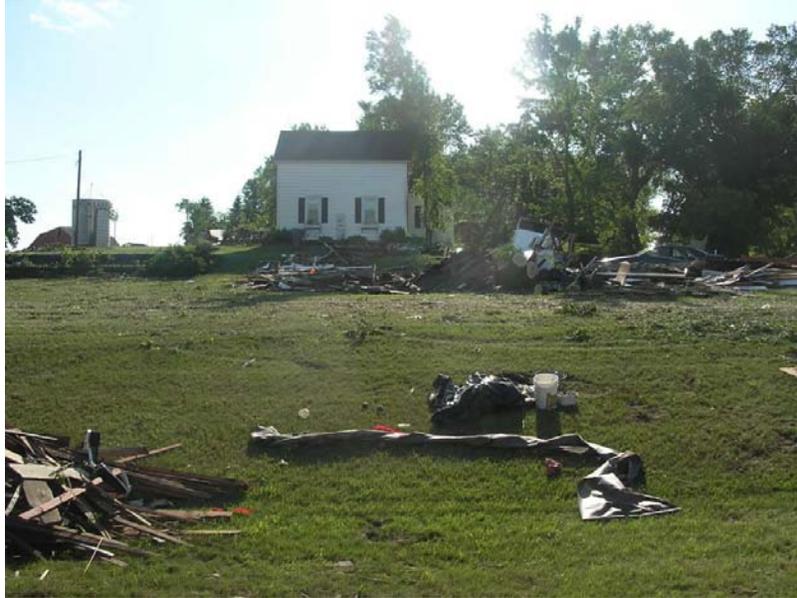
Garage destroyed southwest of Swift Falls.

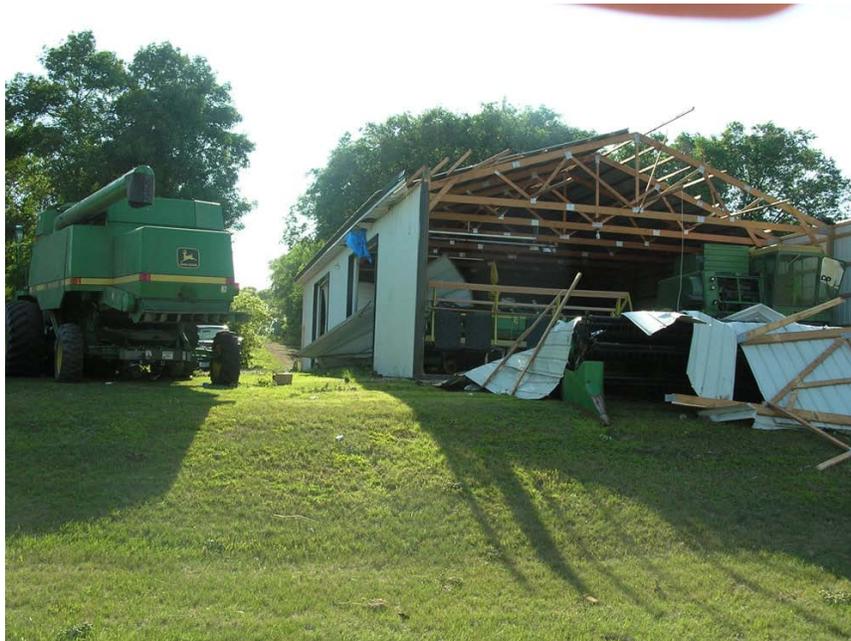
Outbuilding heavily damaged southwest of Swift Falls.

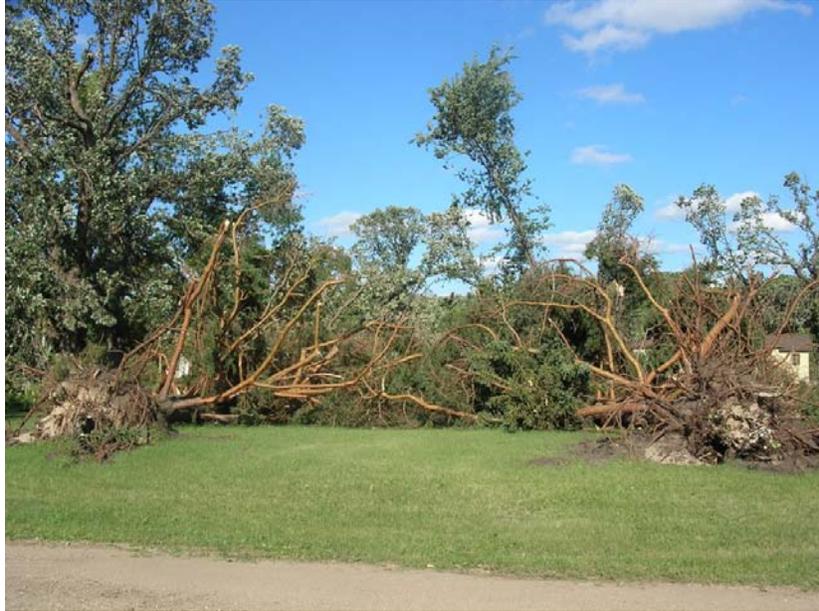
Numerous large trees uprooted and in a convergent damage path within Swift Falls.

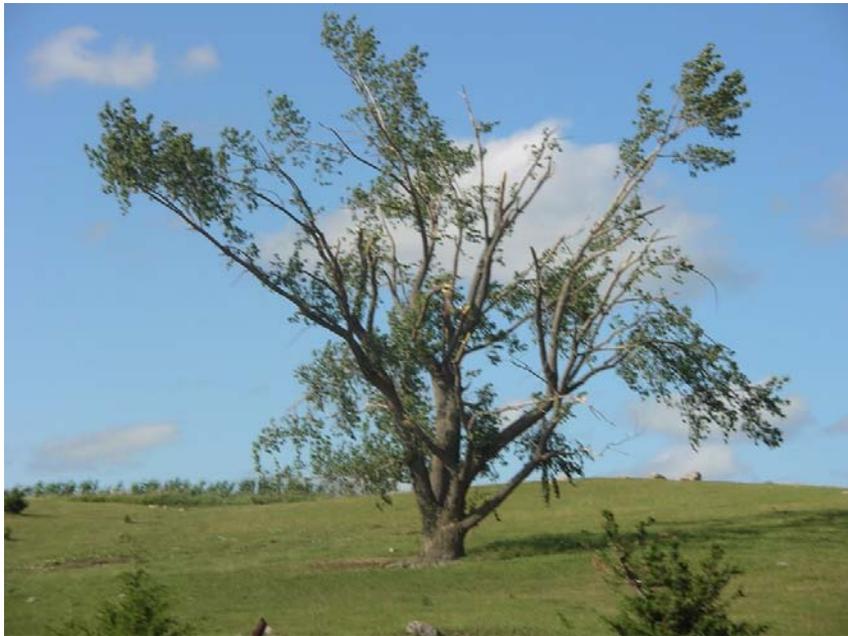
Tree damage northeast of swift Falls

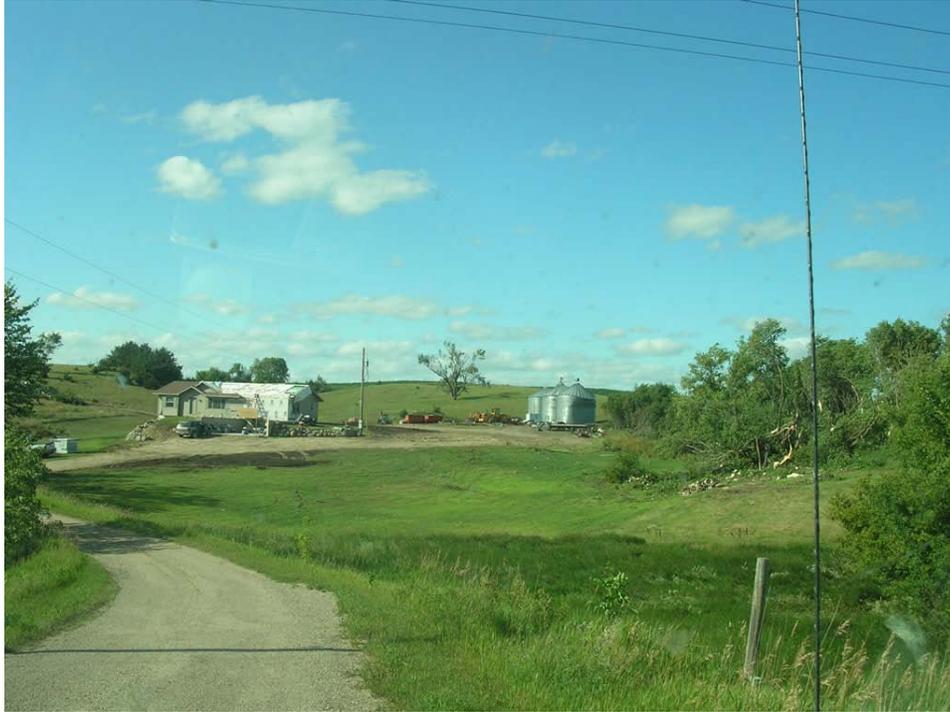
Property and tree damage, including outbuilding destruction, northeast of Swift Falls.

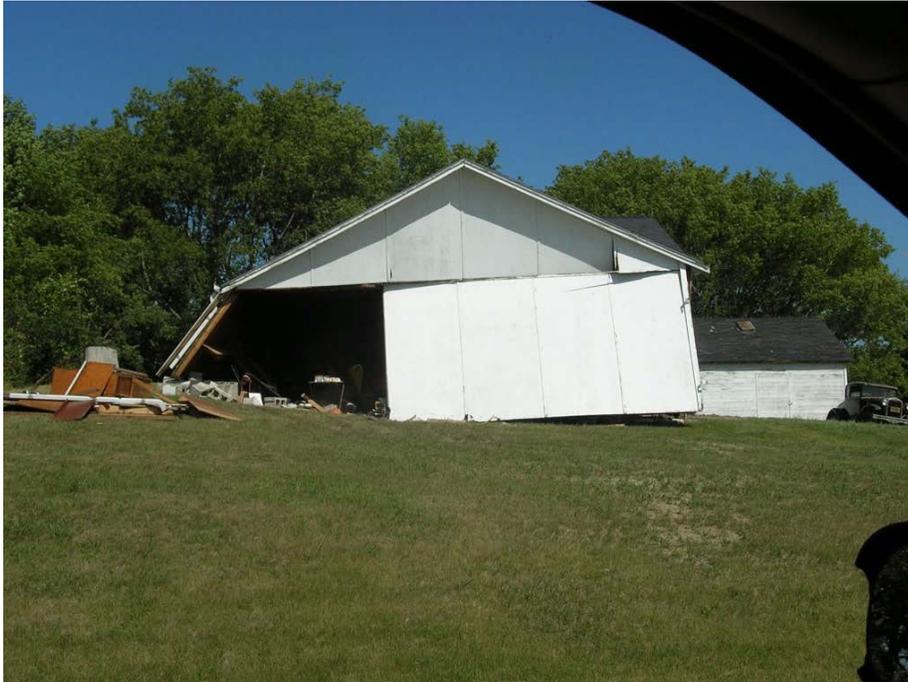
Garage walls collapsed southwest of Spicer.

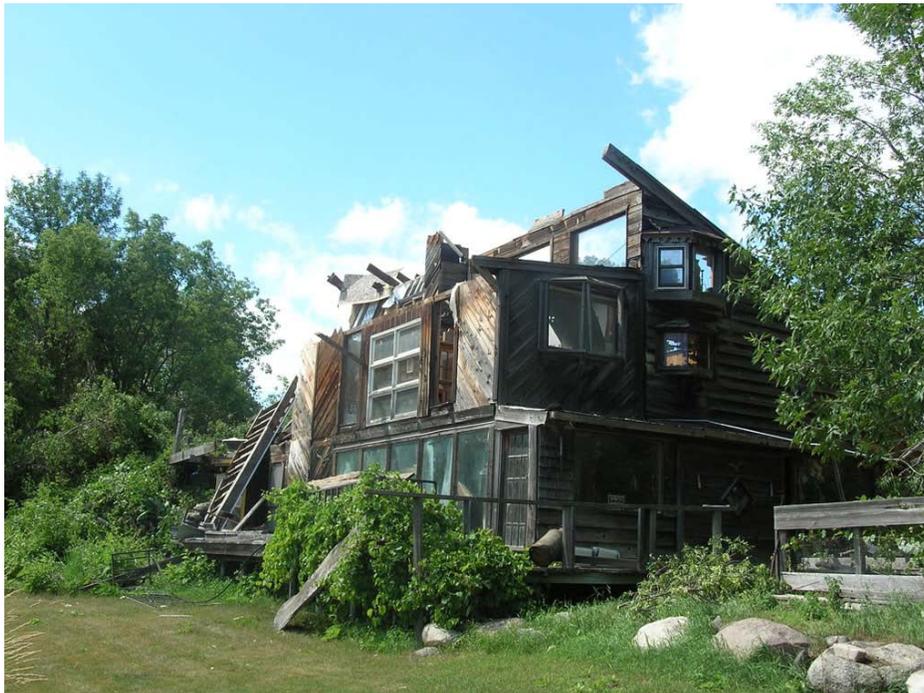
House partially destroyed southwest of Spicer.

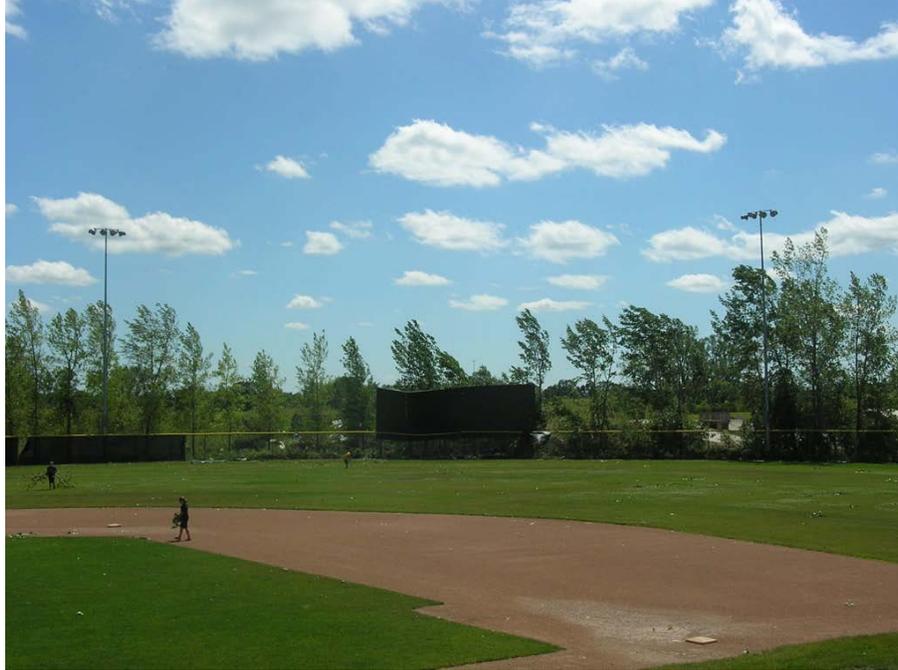
Baseball outfield billboard damaged in Spicer.

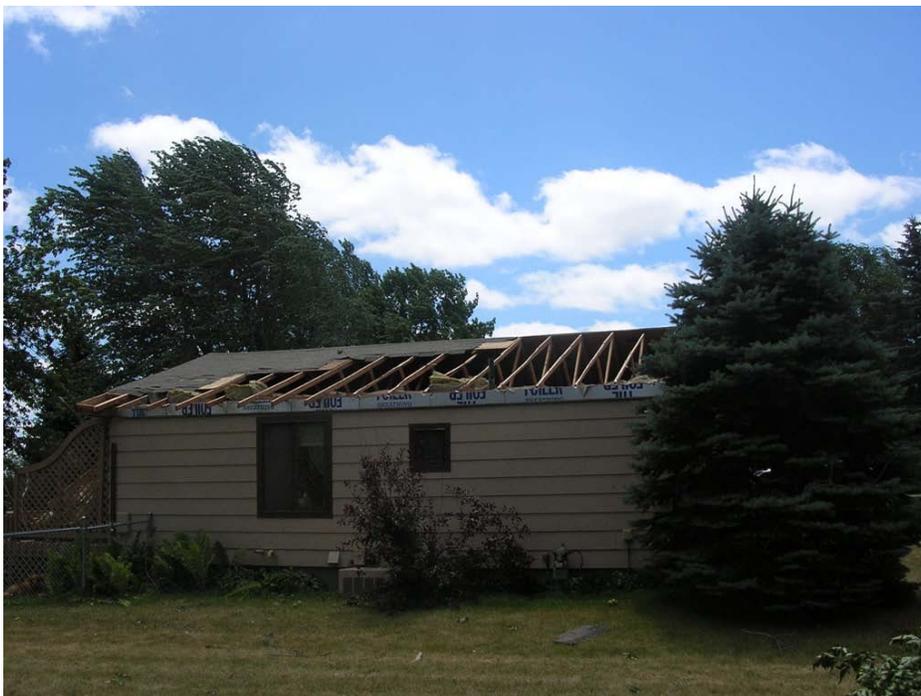
House roof heavily damaged in Spicer.

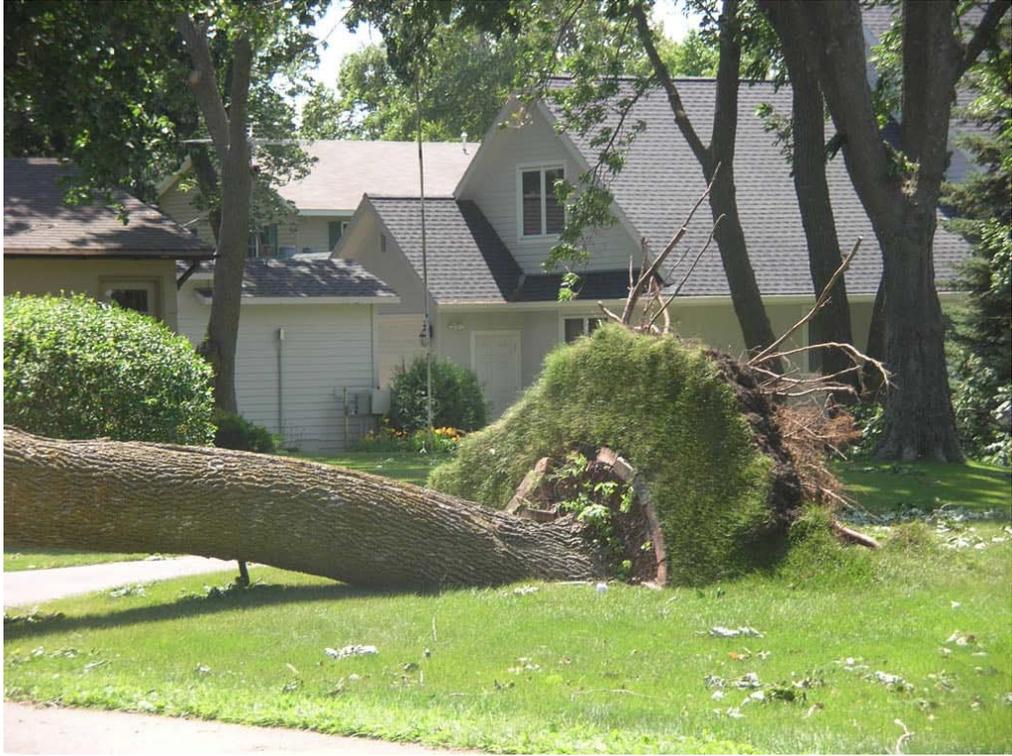
Large tree uprooted near Green Lake.

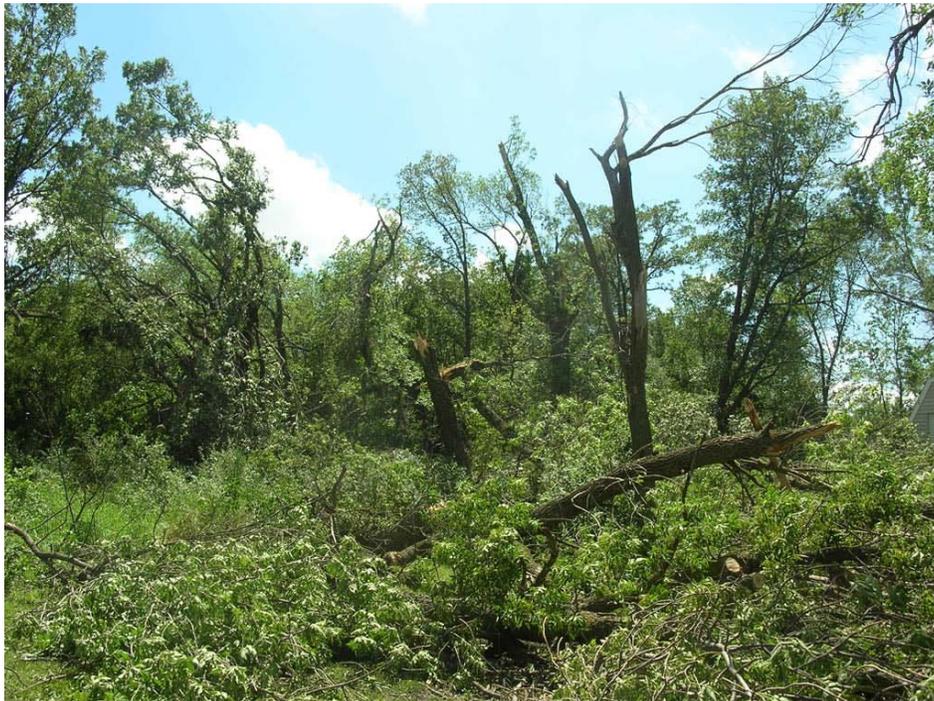
Approximately  $\frac{1}{2}$  mile south of the Spicer tornado was localized but extensive tree damage. The nature, location and timing of this damage was determined to be straight-line winds from the rear flank downdraft of this tornadic thunderstorm. The damage occurred roughly at the same time the tornado was dissipating. Estimated winds were between 90 and 100 mph. Such a phenomena can occur with a strongly rotating thunderstorm and can often happen in the latter period of the tornado cycle.

Straight-line tree damage a few miles east of downtown Spicer.
