The 10th Anniversary of the Dead River Flood

May 14th to May 16th 2003

The Dead River flood begins with the breach of the fuse plug at the Silver Lake Basin located in northwest Marquette County in the Huron Mountains area, roughly 22 miles from the city of Marquette. From Silver Lake, the Dead River flows approximately 27 miles to its outlet into Lake Superior on the north side of the city of Marquette.

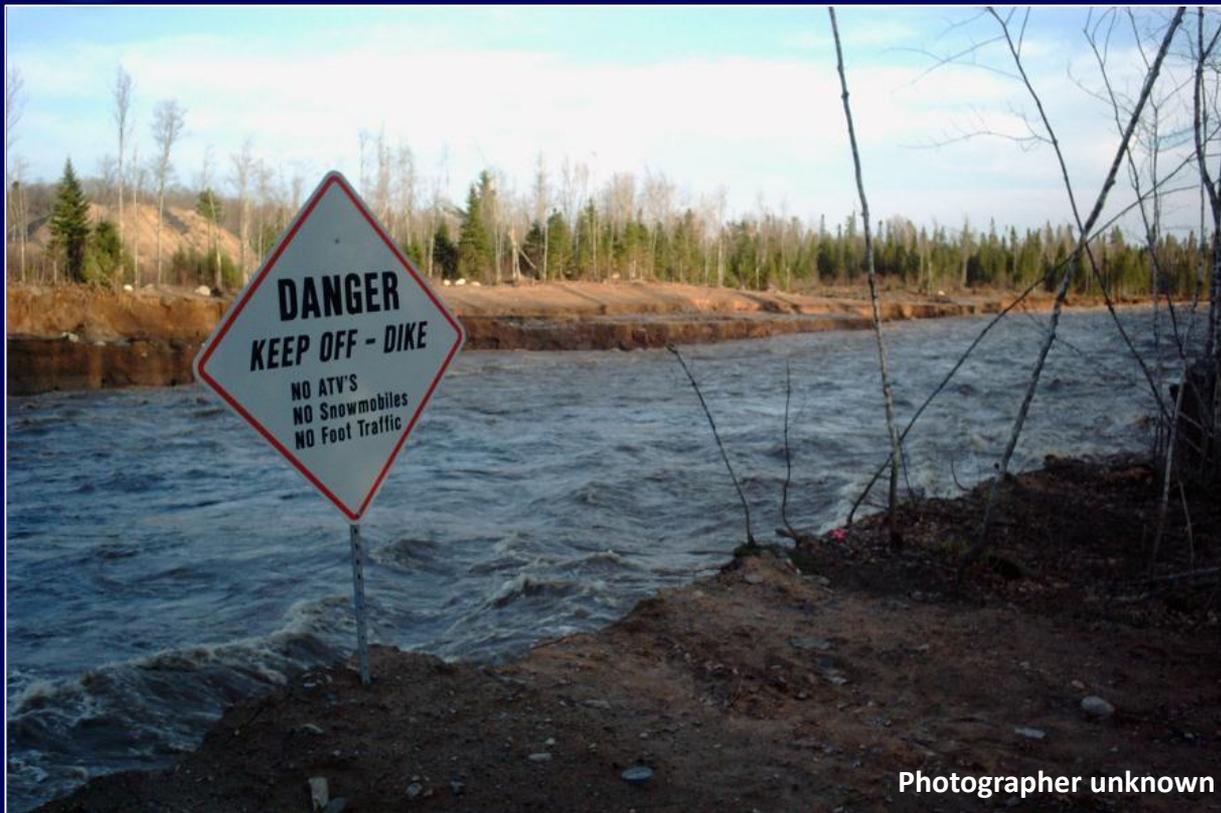
- May 14, 2003. Two days after the end of the heavy rainfall, the Silver Lake Basin fuse plug fails – approximately 5:00 p.m.

Silver Lake fuse plug failure near the beginning of the event

The combination of spring snowmelt and the heavy rain event of May 11th and 12th were contributors to the fuse plug failure.

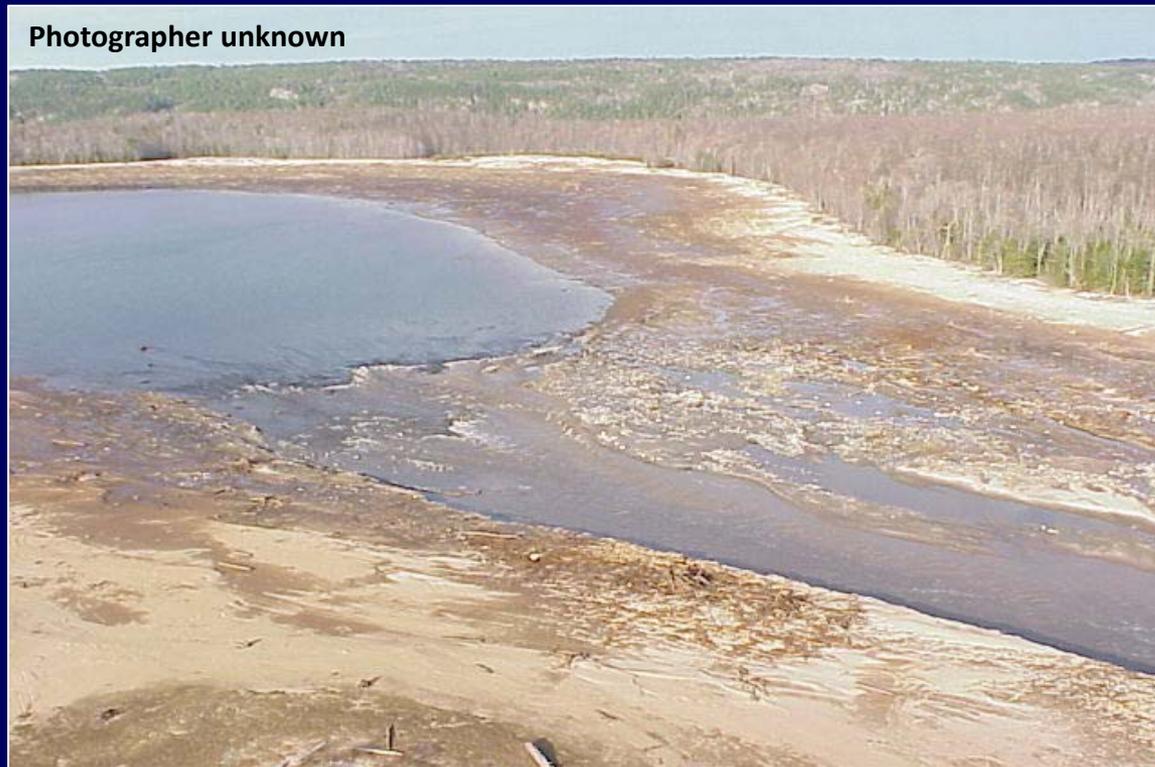
Silver Lake basin breach

Silver Lake reservoir has a surface area of about 1500 acres and a storage capacity of approximately 34,000 acre-feet. Through the section of the fuse plug that failed at Silver Lake, the rapidly flowing water carved out a new channel approximately 100 yards wide by 25 feet deep and one-half mile long. It was estimated that 25,300 acre-feet of water passed through the new channel with the remaining water being held back by a high point in the lake bottom.

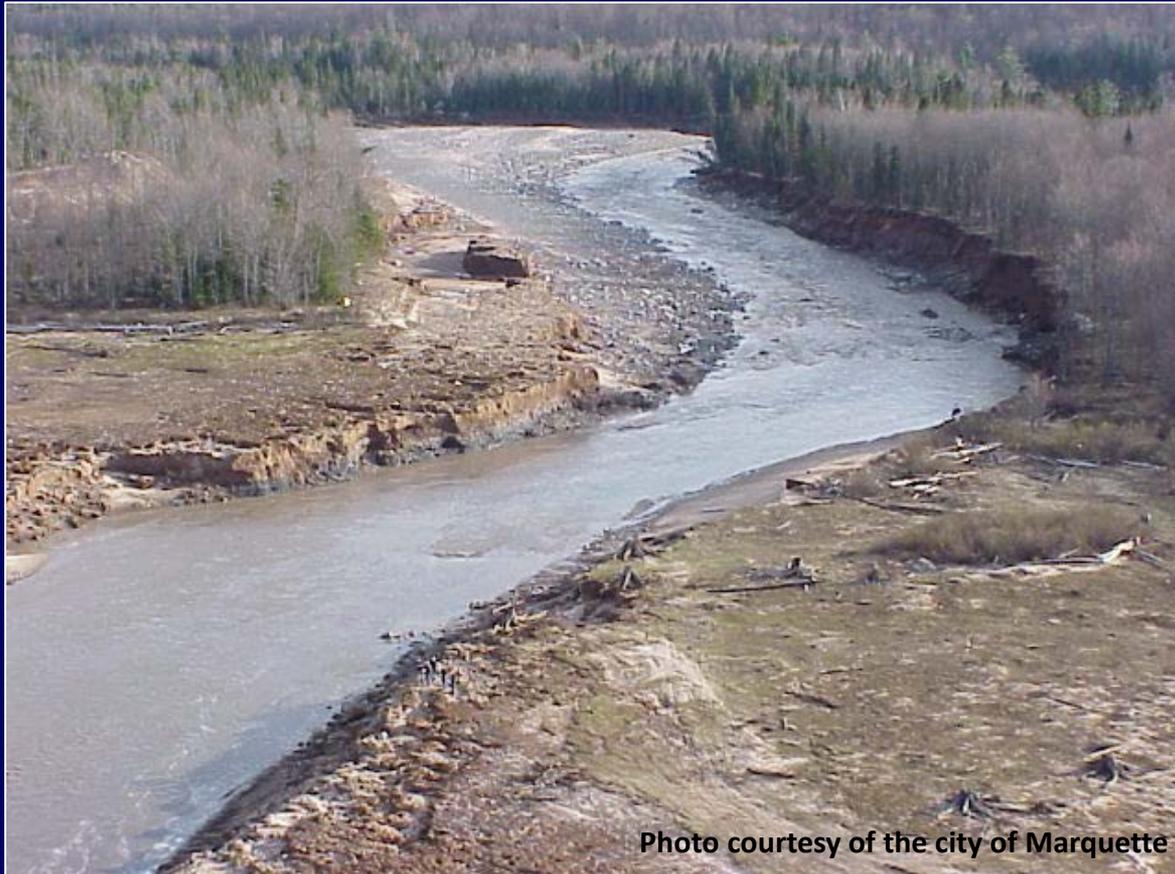
Just downriver from Silver Lake

- Break unleashed an estimated 8-9 billion gallons of water downriver from Silver Lake.

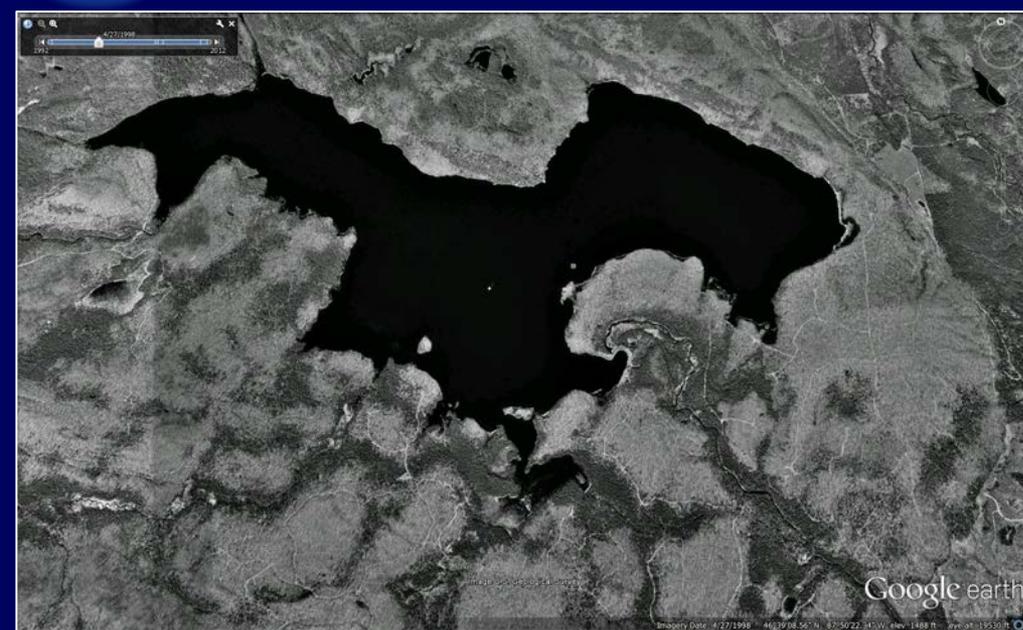
Silver Lake basin in 1998.

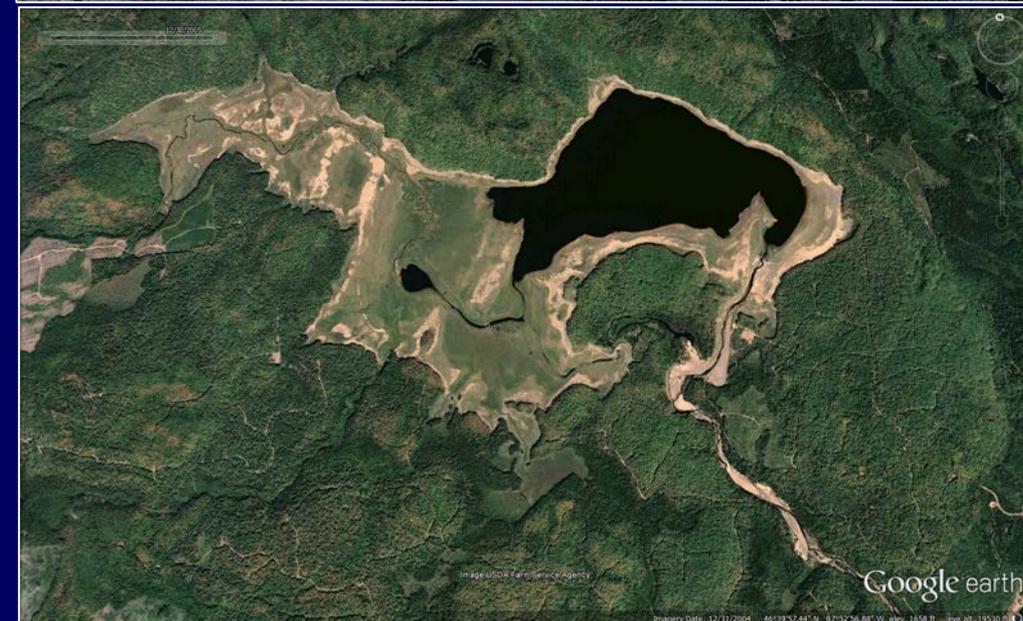
Silver Lake basin in 2005, two years after the flood.

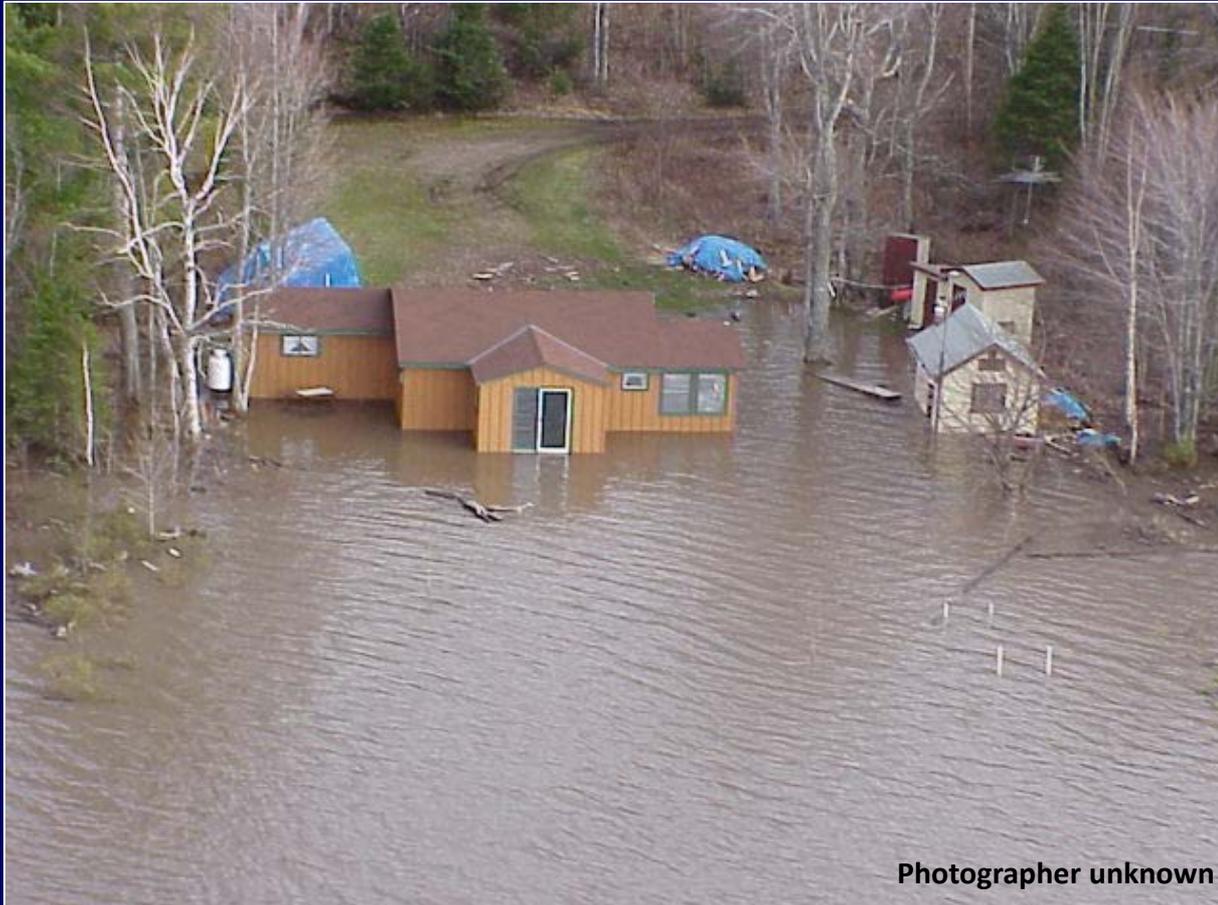
Dead River Basin

- Floodwaters reach Dead River Basin, damaging camps and homes

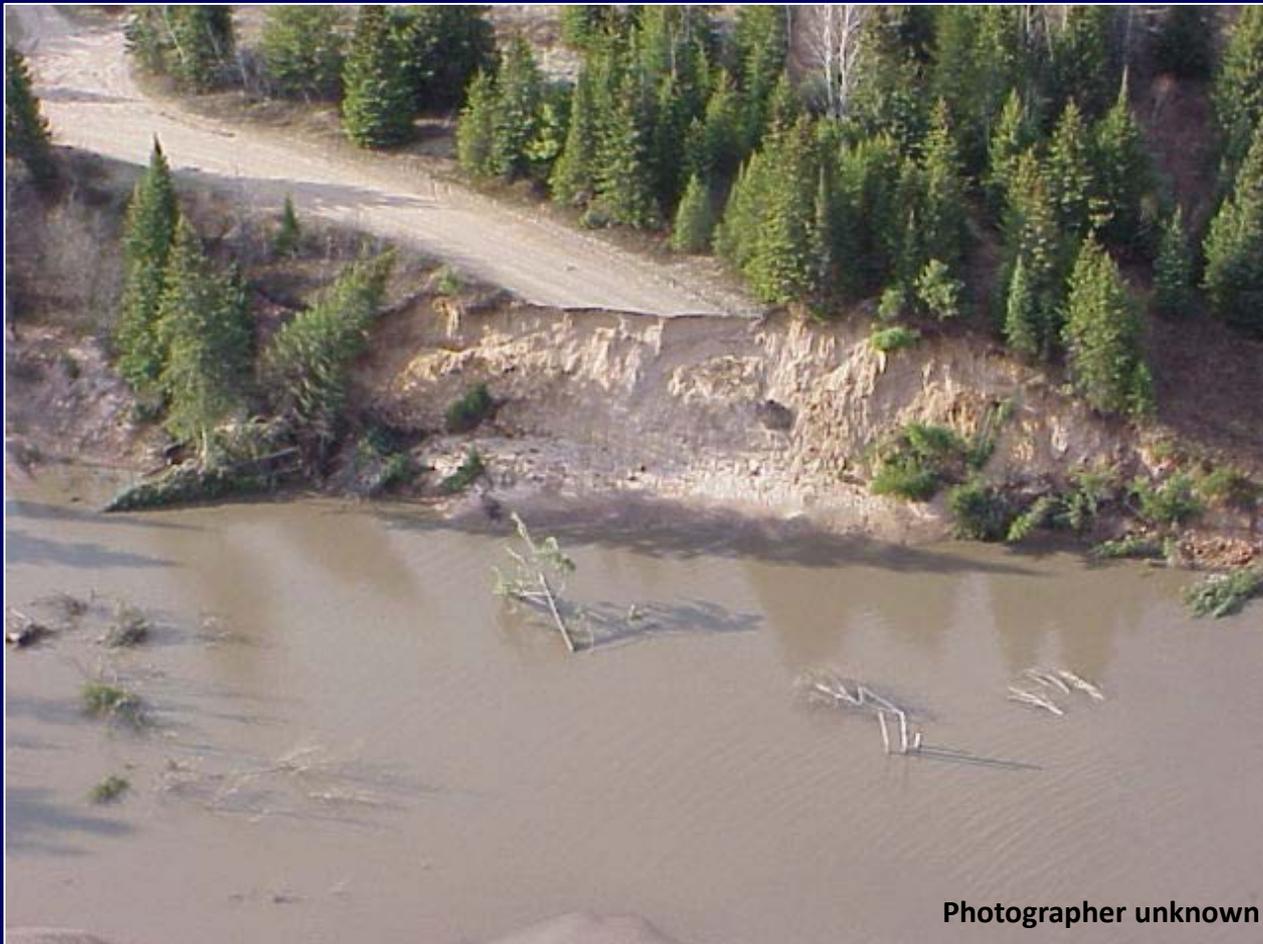
Dead River Basin

- The torrent of water also destroys roads along the way

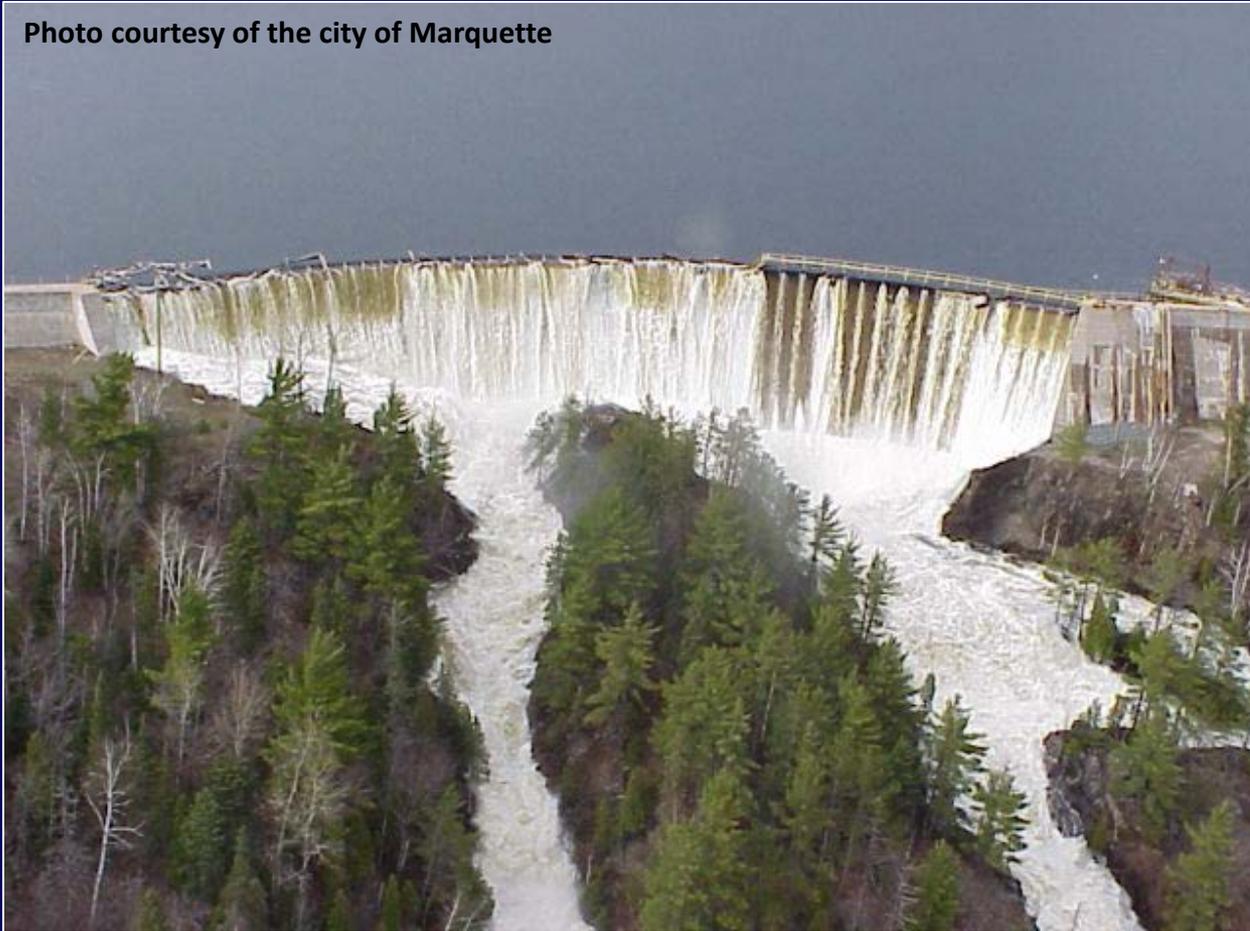
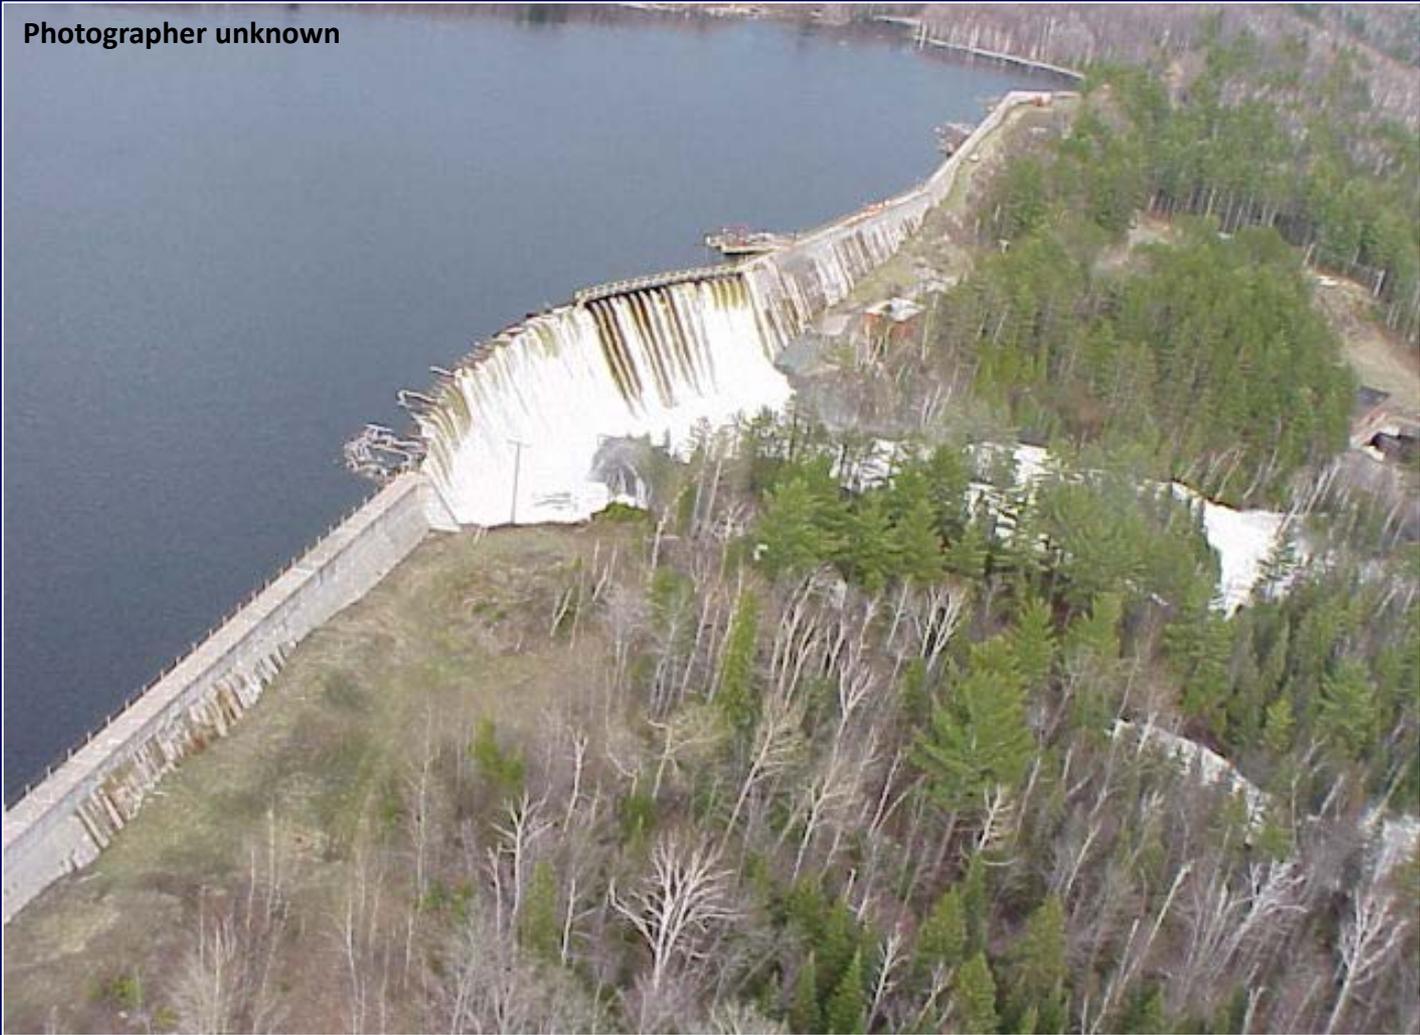
- Floodwaters crest the Hoist Dam and flow further downriver
- Peak water level at the Hoist Dam was 4.44 feet above the spillway level

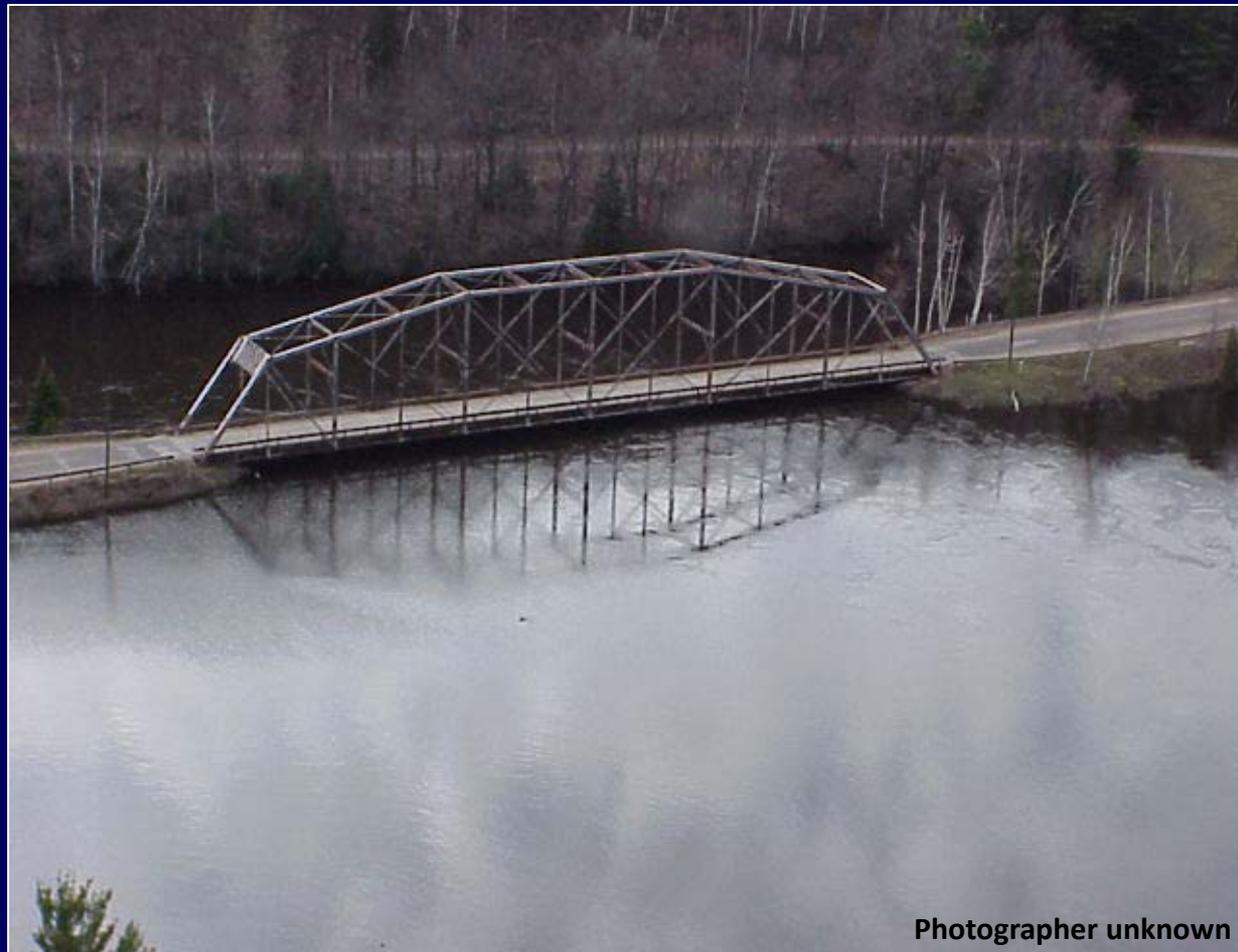
CR 510 Steel Bridge

- Water continues downstream, crossing CR 510 (Steel Bridge)

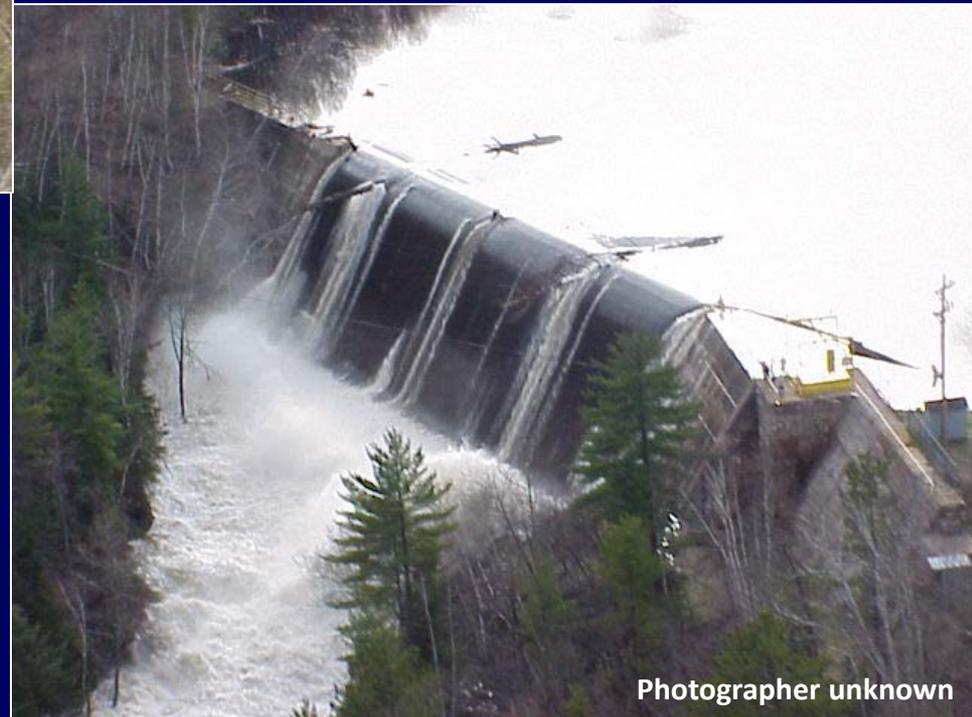
- Downriver, the floodwaters crest the McClure Dam
- Peak water level at the McClure Dam was 5.13 feet above the spillway level

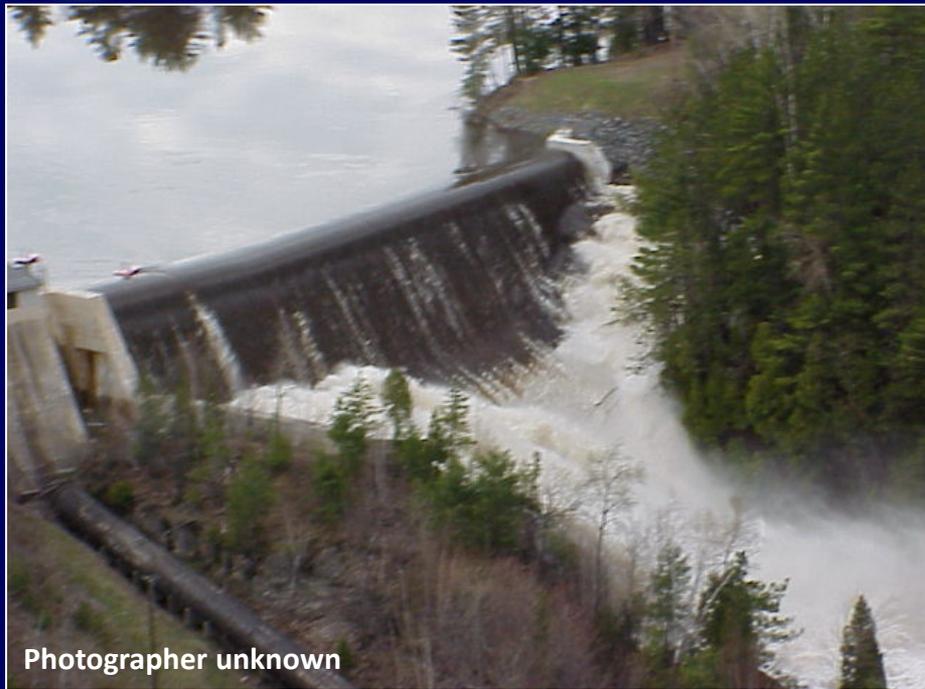
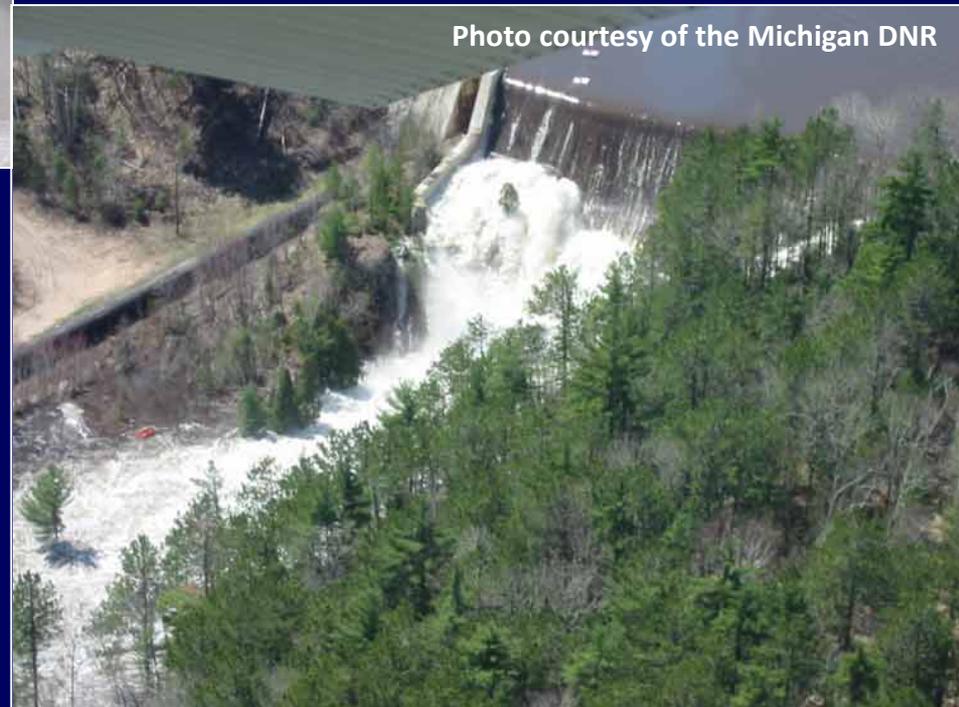
- Floodwaters reach Forestville Dam
- Peak water level at the Forestville Dam was 4.4 feet above the spillway level

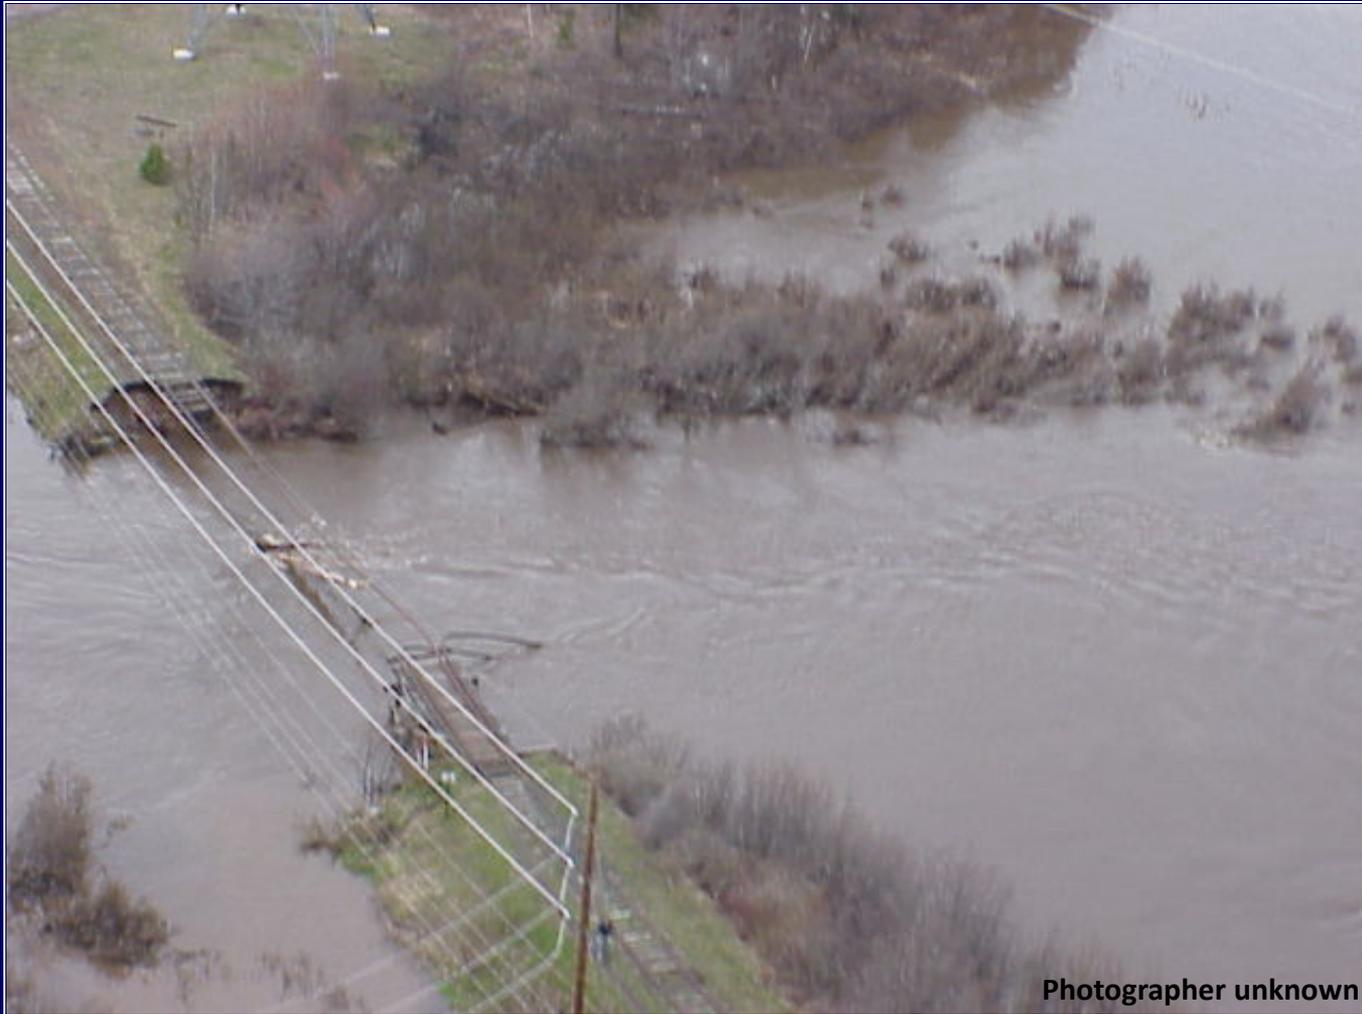
- Floodwaters destroy train trestle

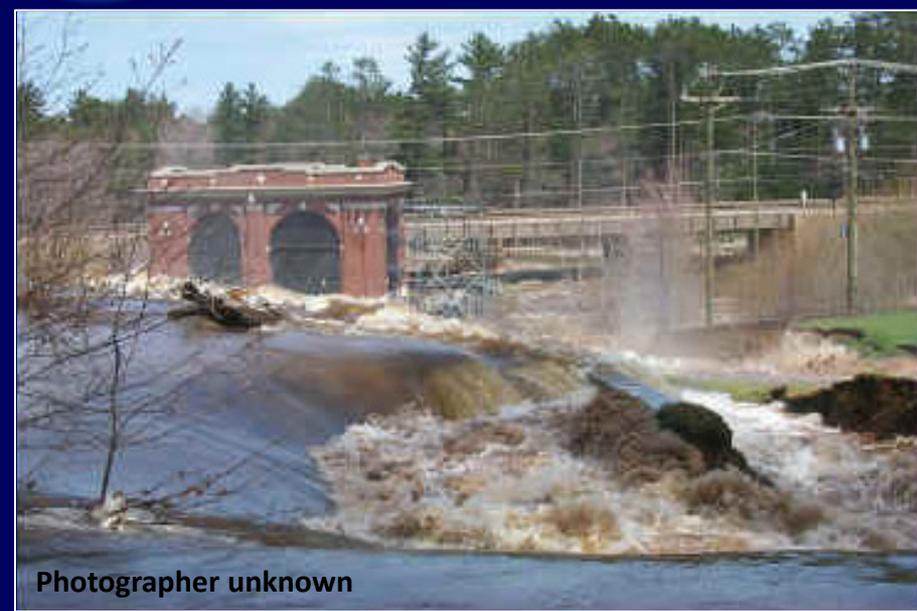
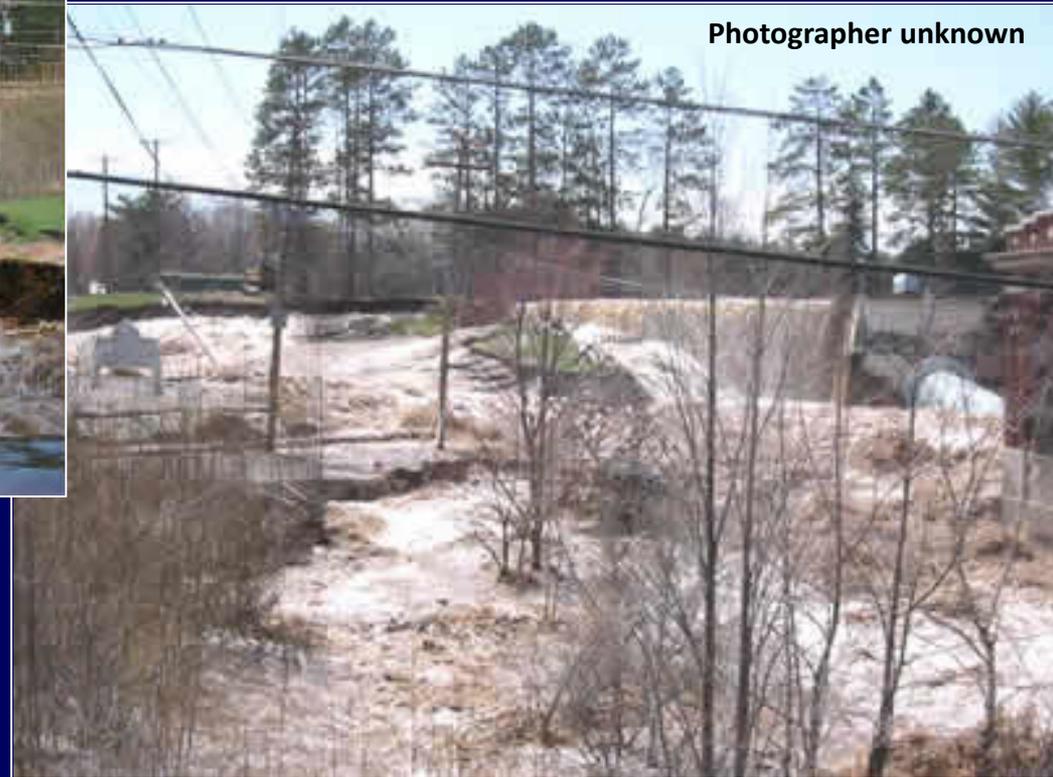
Tourist Park
Marquette

Flood water reaches Tourist Park. Despite the water level being drawn down 5 feet behind the Tourist Park dam prior to the arrival of the flood wave, water still overtops the dam, and the water also carves out an outlet around the dam near the swimming area.

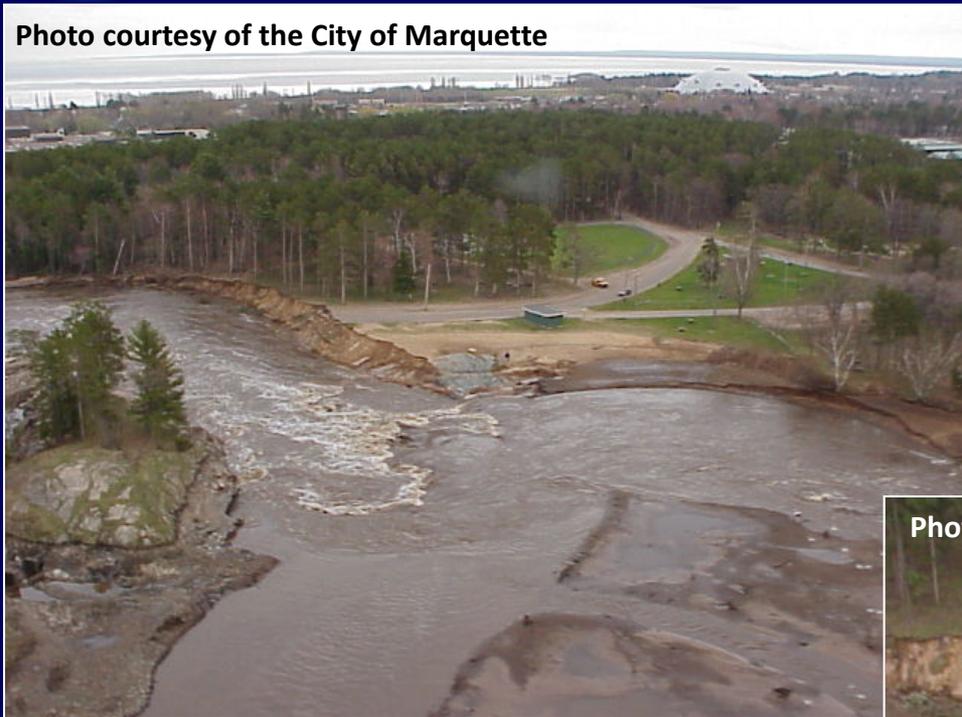
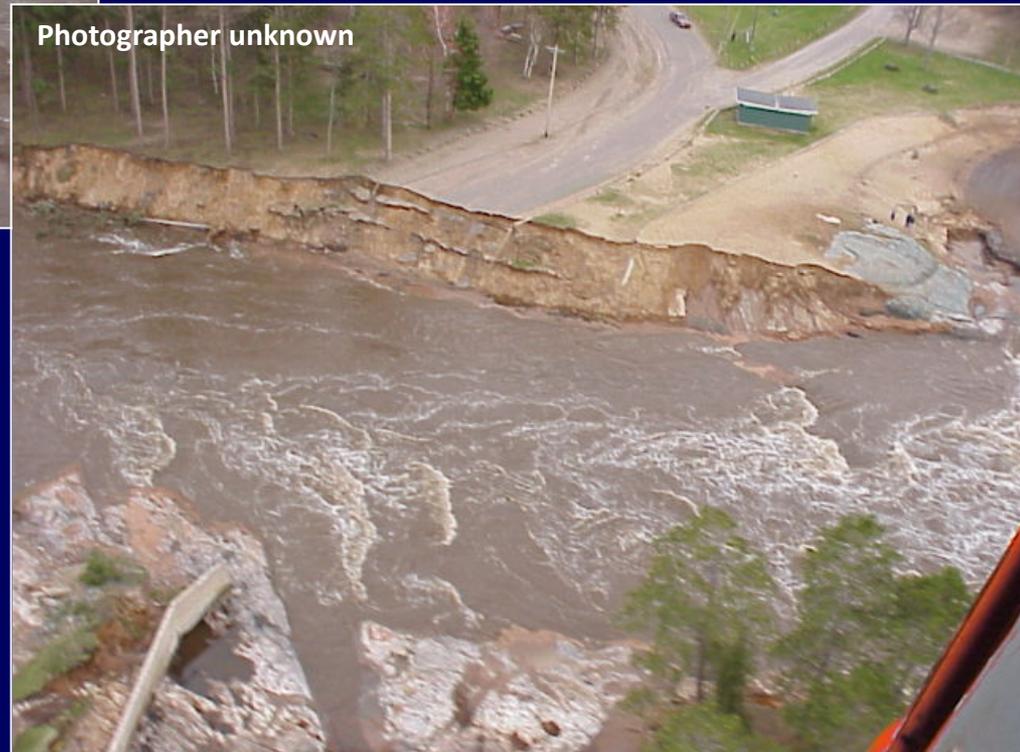
Tourist Park damage
in Marquette

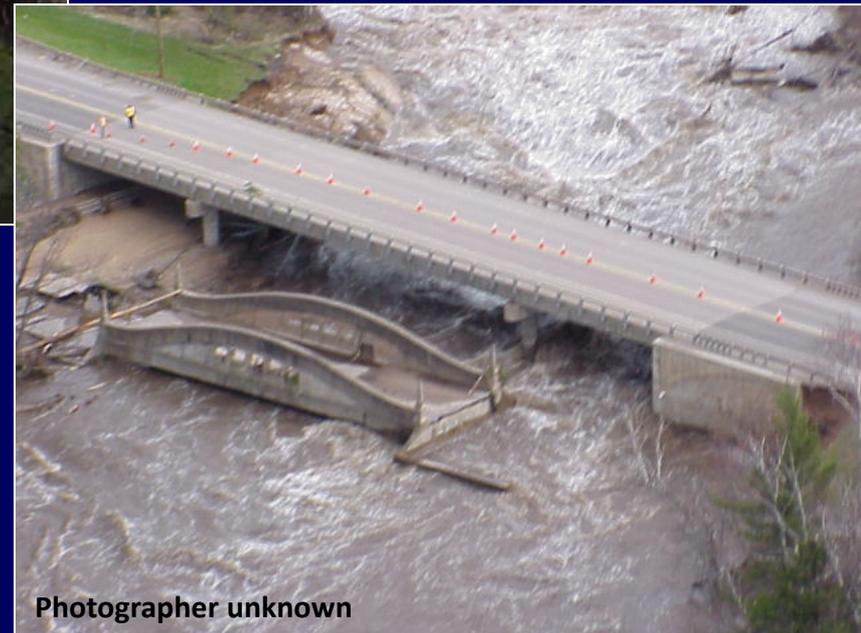
CR 550 near Tourist
Park in Marquette

- Flood damages bridges on CR 550
- Utility service interrupted to Big Bay

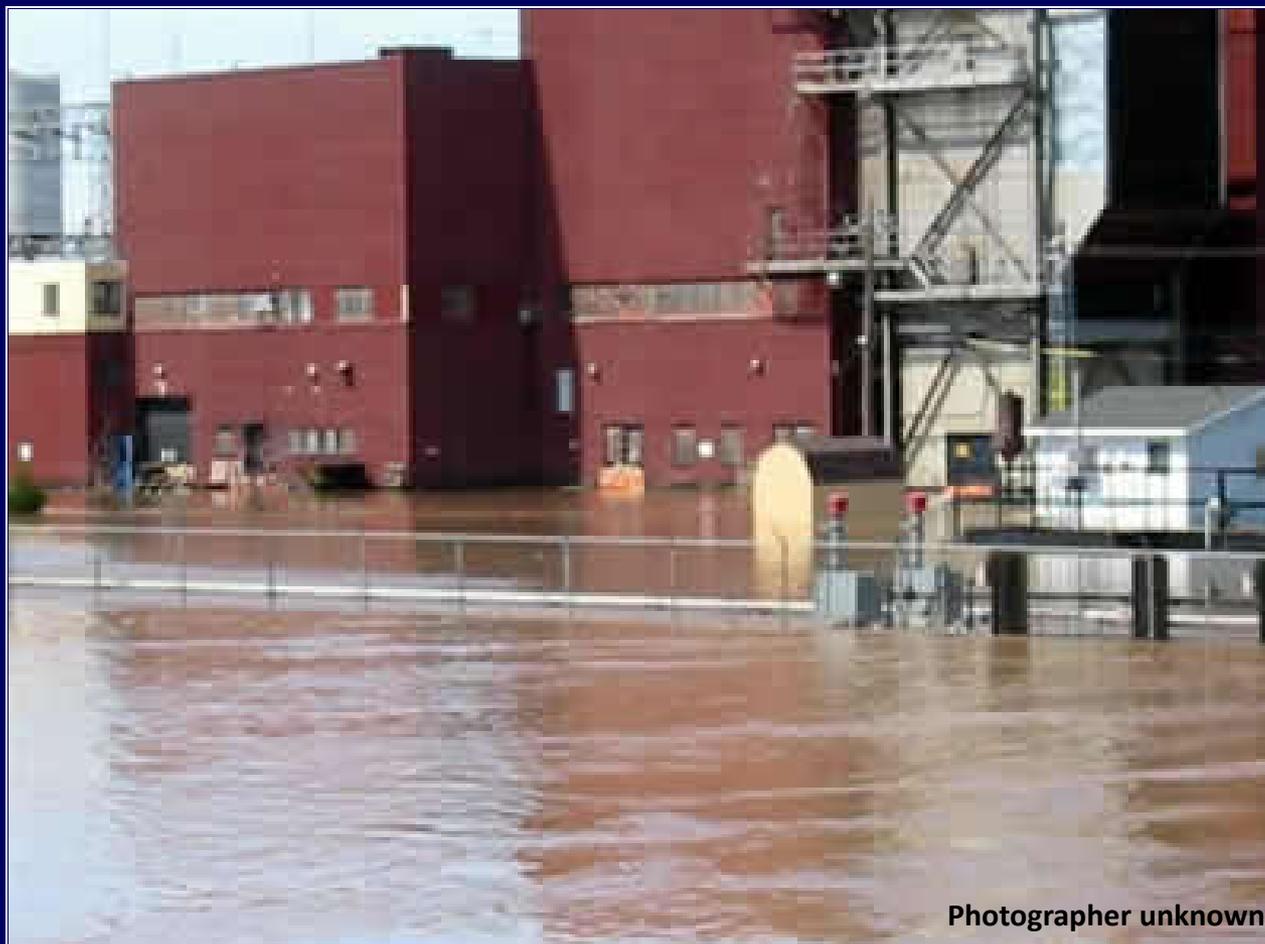
Presque Isle Power Plant in Marquette

- Considerable damage to Presque Isle Power Plant

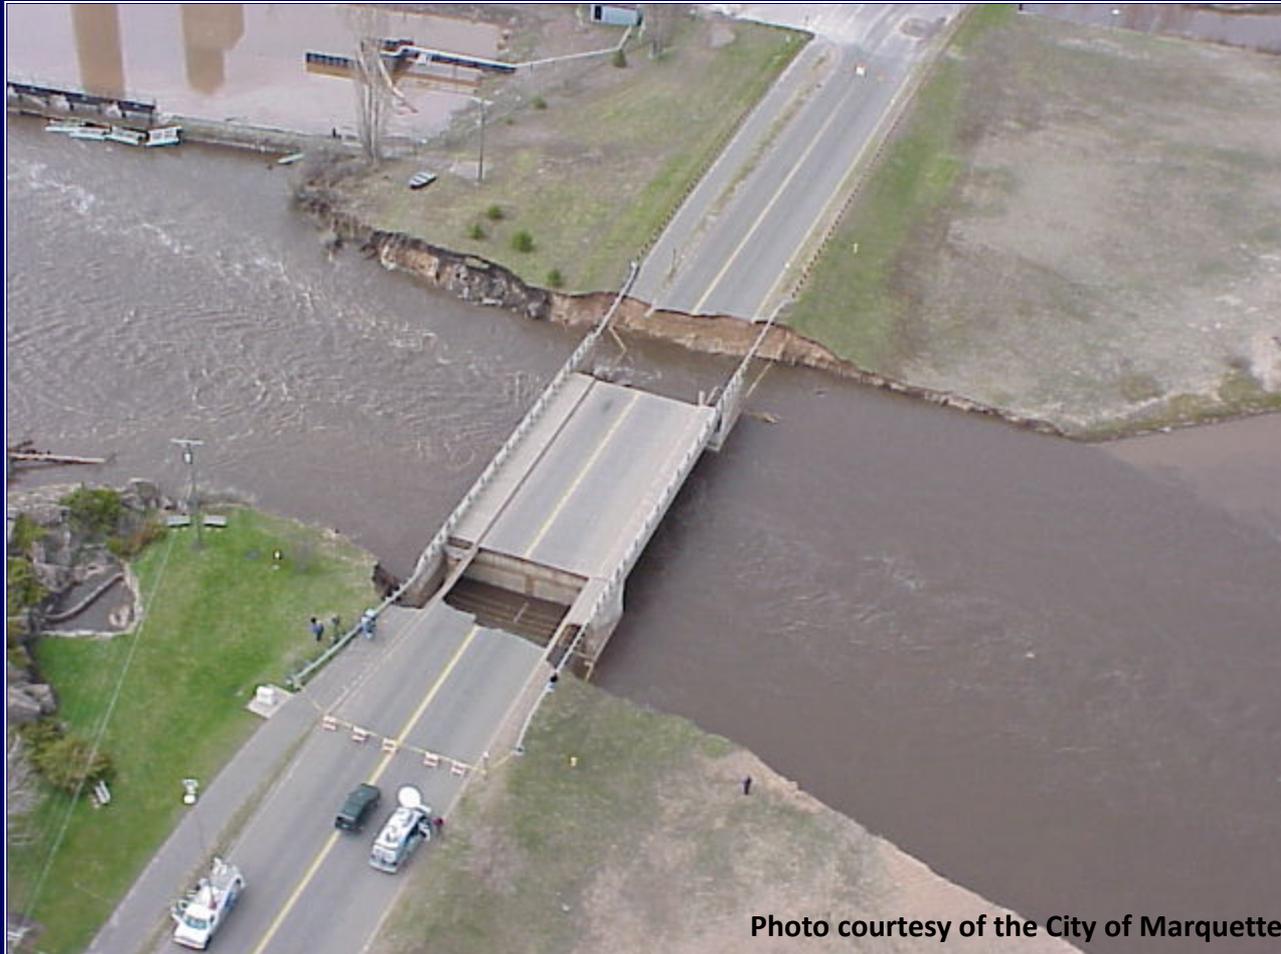
Lakeshore Boulevard in Marquette

- Flood waters destroy bridge approaches on Lakeshore Boulevard
- Cuts power, gas, and telephone service to residences

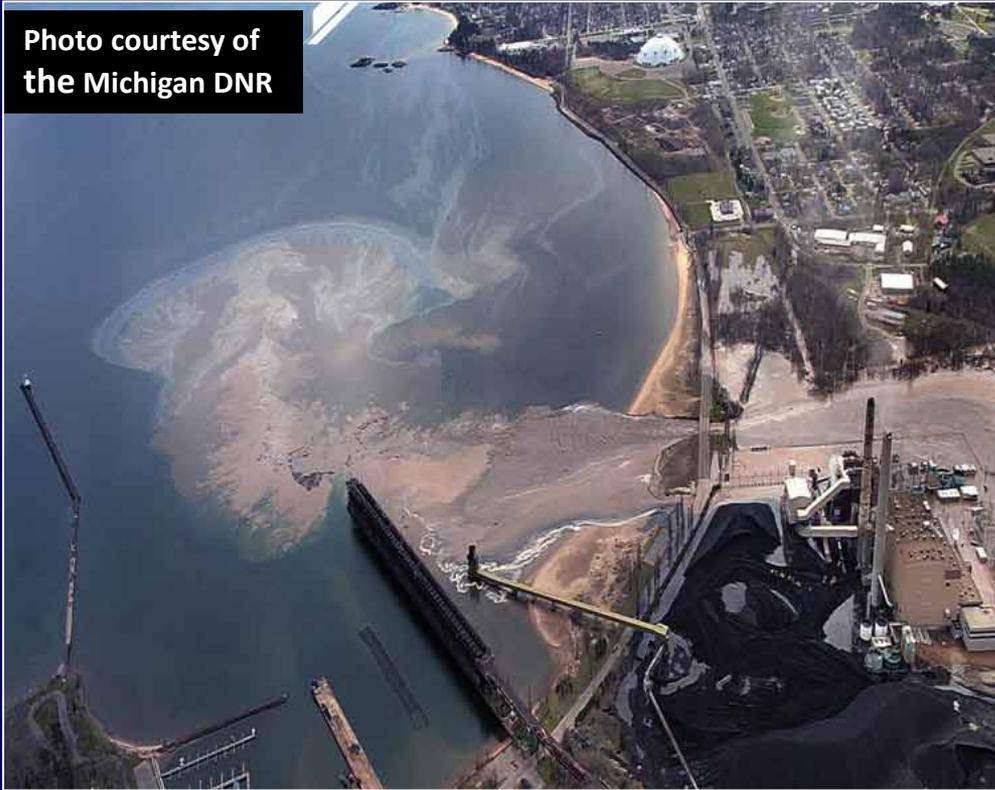
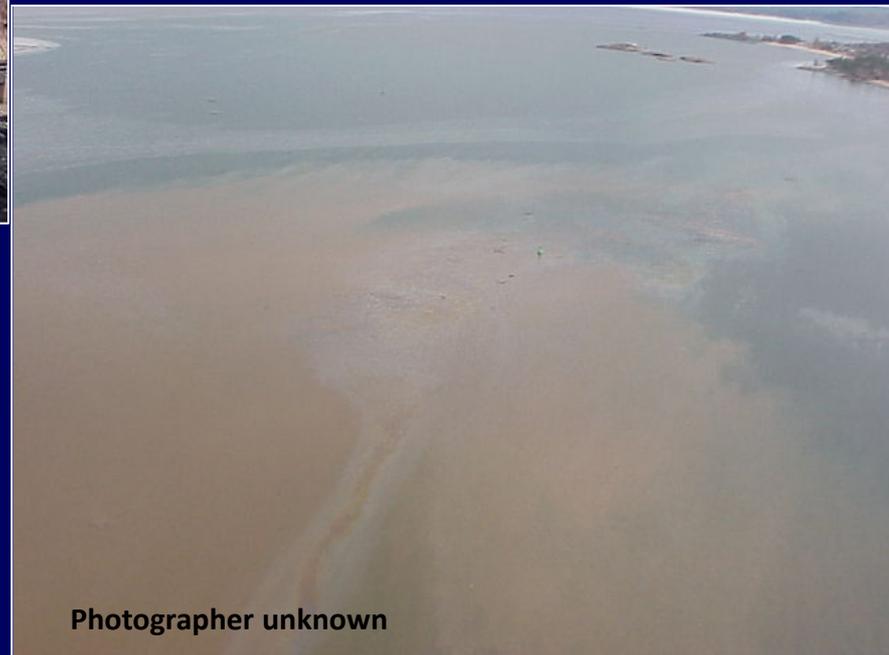
Mouth of Dead River. Presque Isle Power
Plant in lower right of photo

- Silt and debris flow into
Lake Superior
