Preliminary Damage Survey Report:
Wind Damage Event
1 mile North of Ellicott – 5 miles North of Ellicott
May 22, 2006

1. Summary

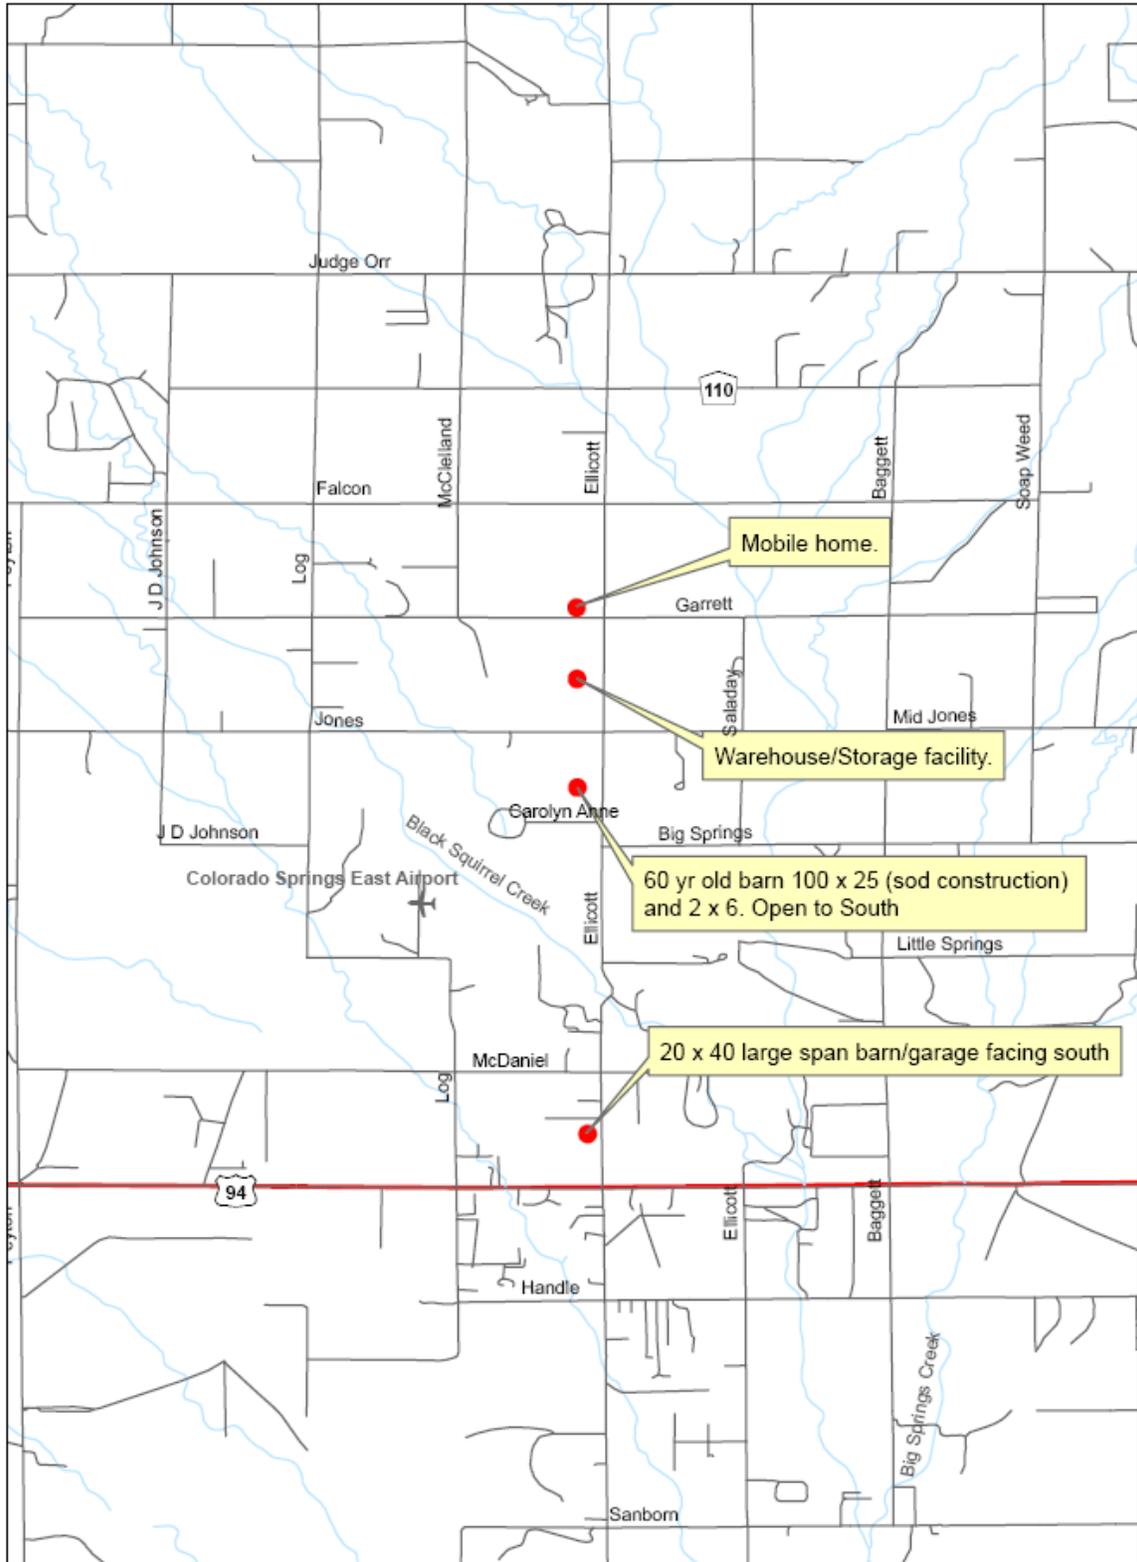
Figure 10. Map of approximate damage locations

Mr. Fortune determined there was sporadic wind damage along and just west of Ellicott Highway from about 1 mile north of Highway 94 to about 5 miles north of Highway 94 (a 4 mile damage path). The damage area was roughly 100 yards wide at the maximum. All of the structural damage was to individual large span structures which had a south exposure (pole barns, large sheds, etc), or that were oriented from east to west making them vulnerable to a strong south wind. Damage also occurred to other more substantial structures, but this damage was caused by the debris from the large span structures. The debris was found to be aligned in a divergent pattern extending from south to north. This type of damage pattern indicated that the damage was likely caused by straight line winds, with speeds ranging between 70 and 80 mph.
